## Stream valleys in the Arnsberg Forest

LIFE-Project 2009 - 2014

# LIFE Project „Stream valleys in the Arnsberg Forest“

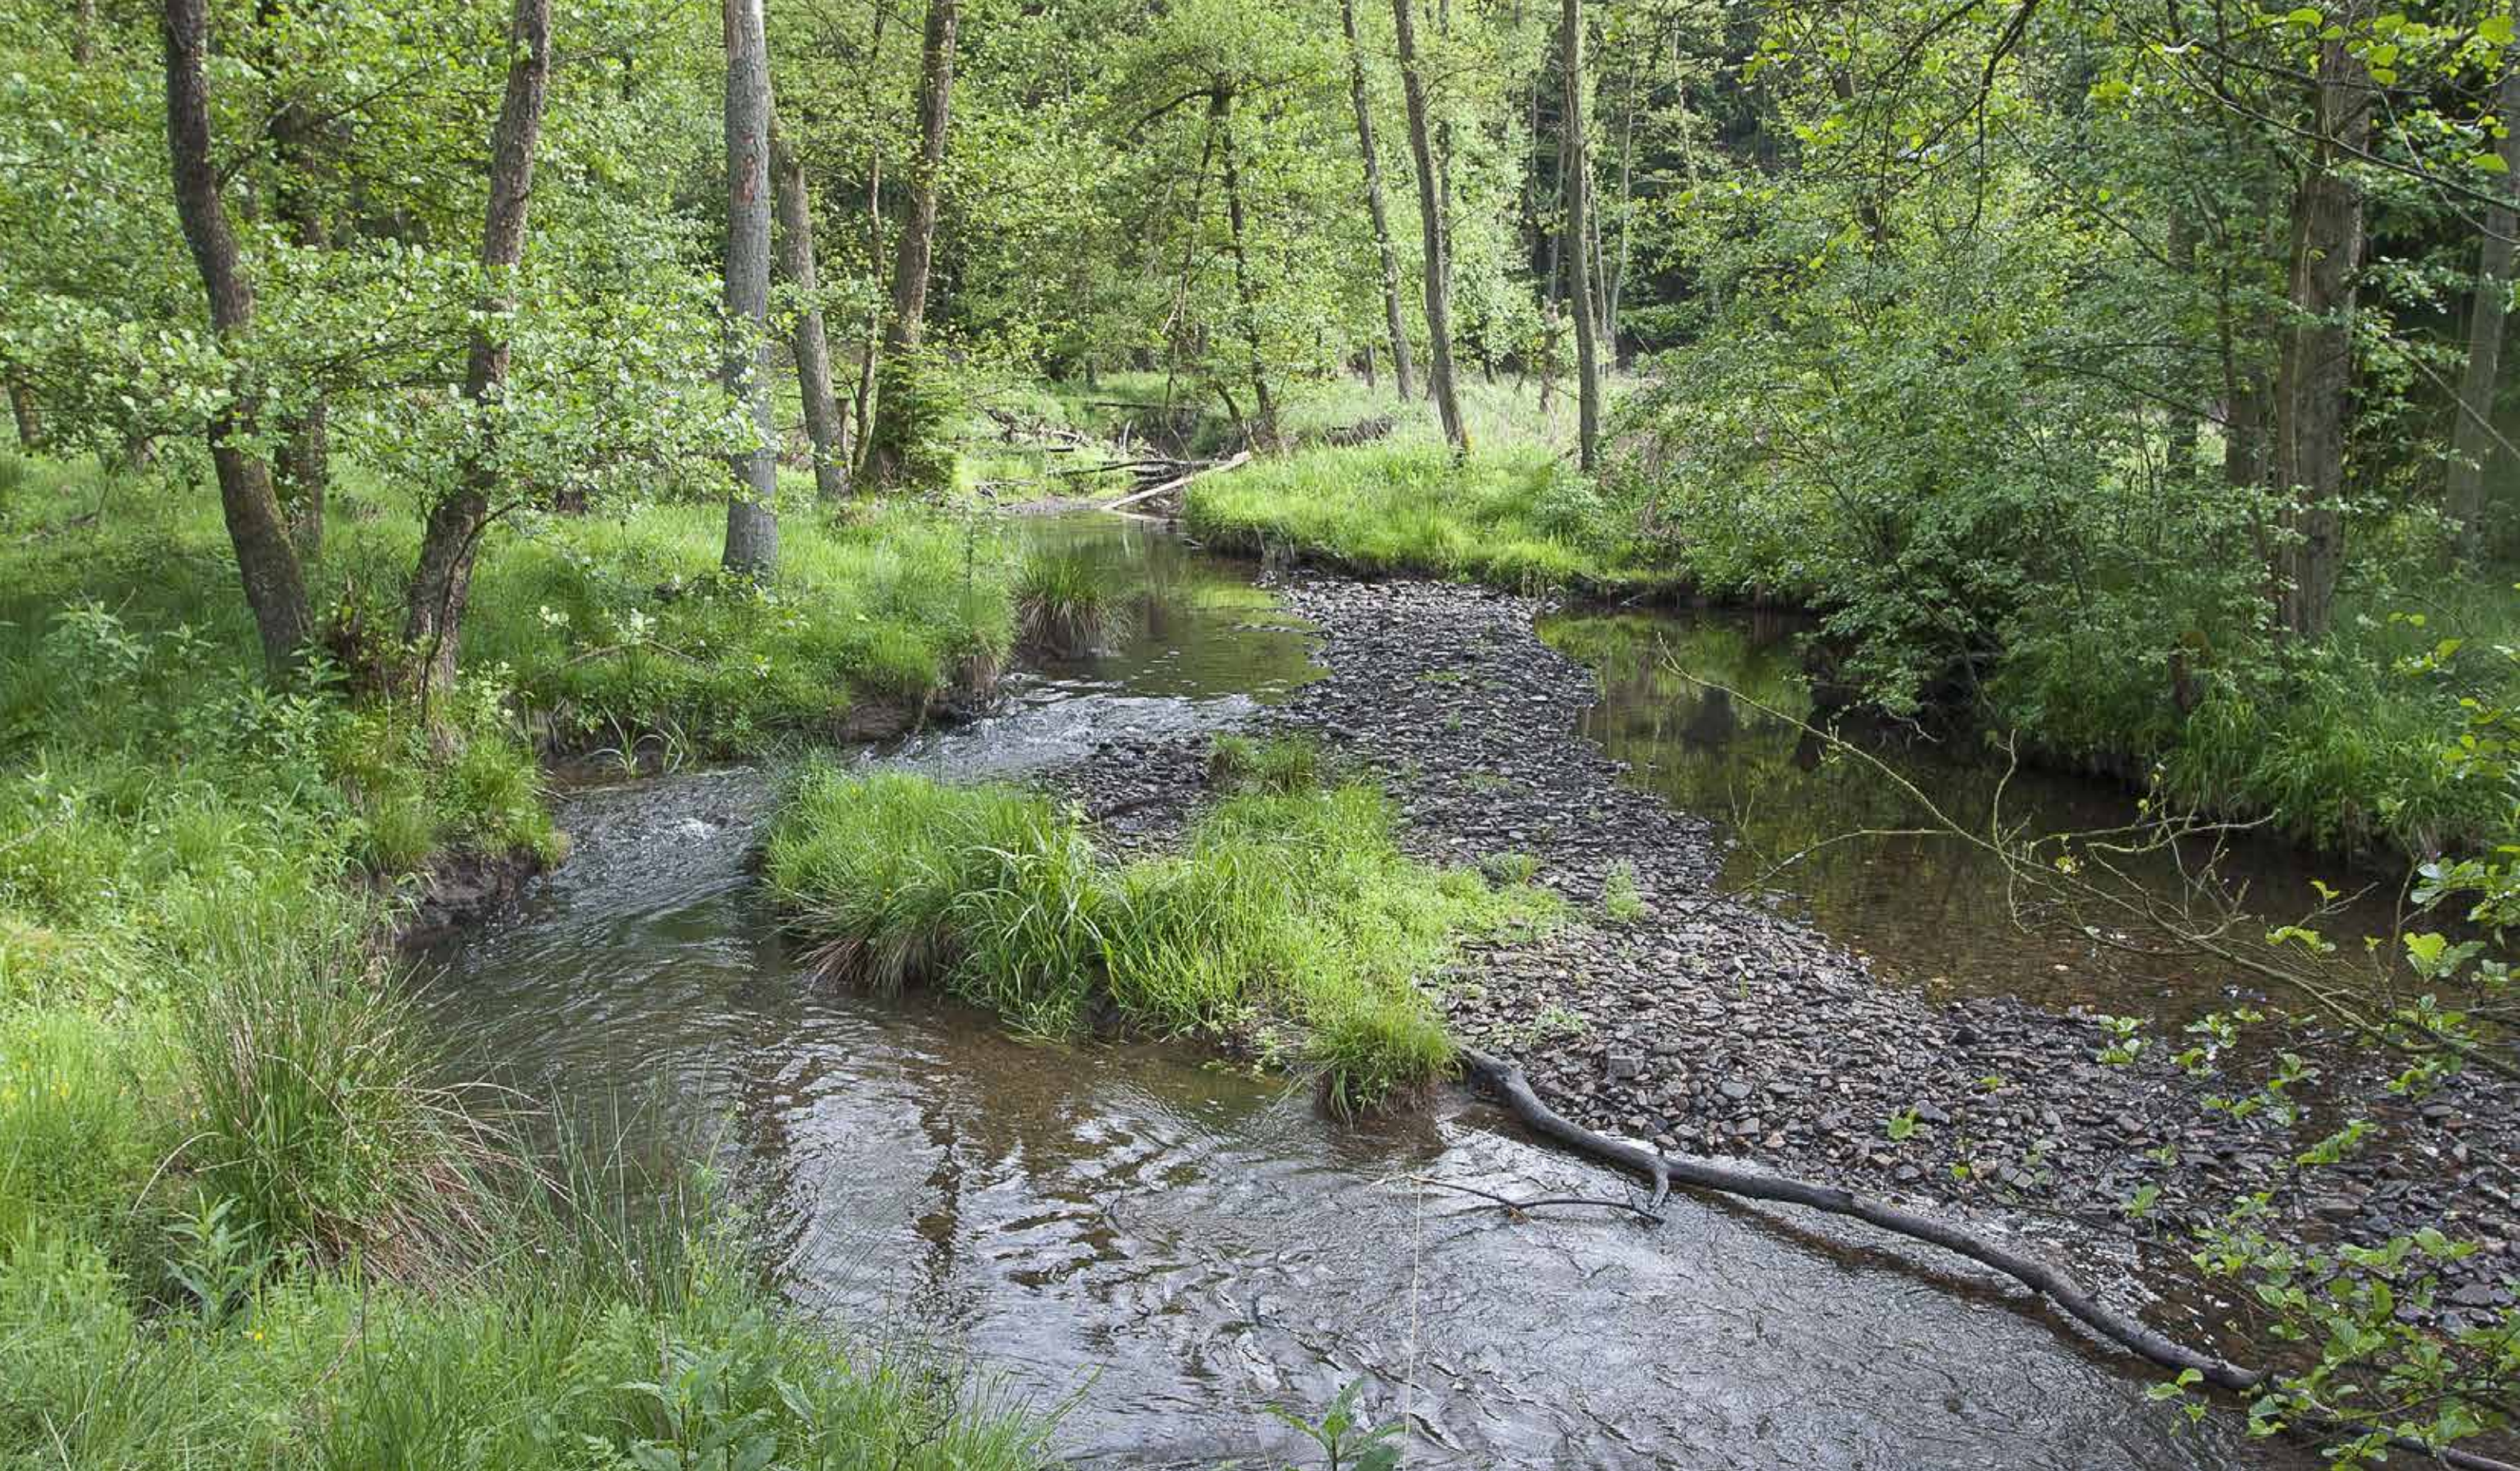
In the area covered by the LIFE project there are numerous near-natural stream sections that give a very good impression of how the natural condition would look. The photo shows the near-natural Heve. It is broad and only cuts slightly into the floor of the level flood plain. The bed of the stream mainly consists of gravels. Pools of slowly-flowing water alternate with riffles (shallow rapids). The alluvial alder forest is flooded with light.

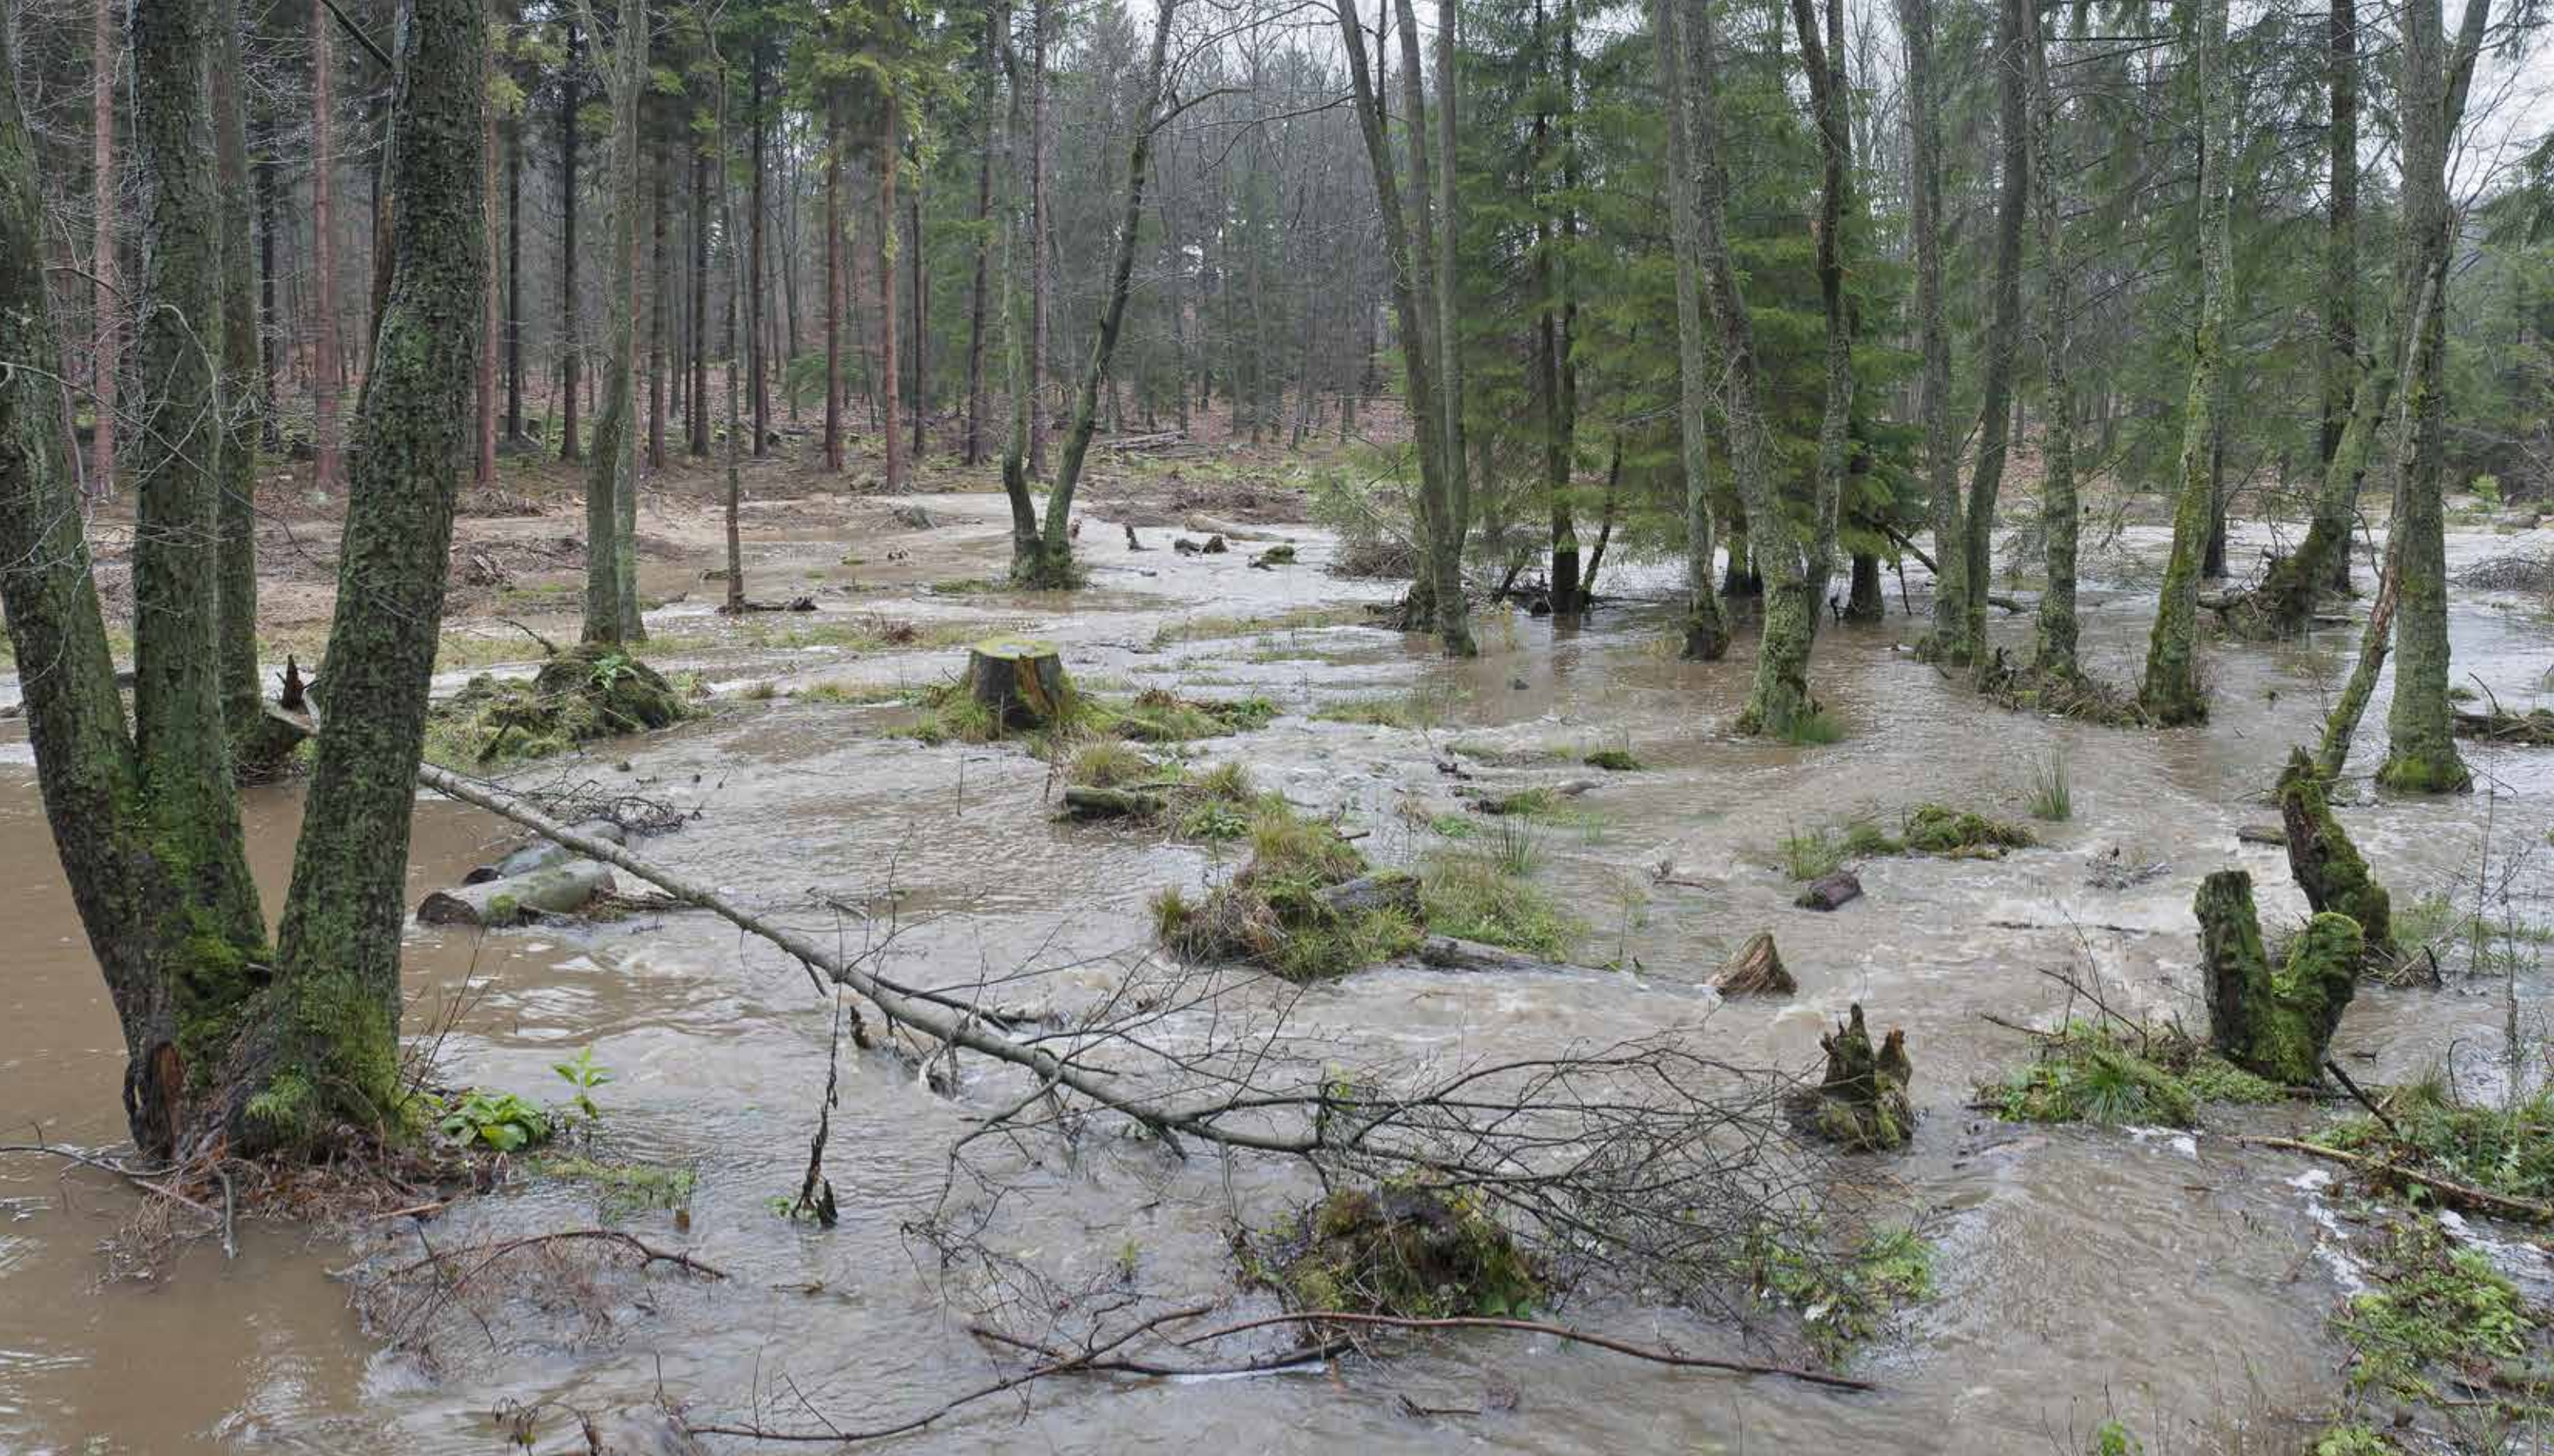
Floodwater streams through the valley of the Kleine Schmalenau. The meandering, near-natural course of the stream can no longer be seen. As the stream only transports a small portion of the water volume, its gravel bed is protected from the destructive force of the flood. The floodplain provides the inundation zone and benefits because seeds are spread by the high water, which also exposes patches of bare soil that later serve as a germination bed..

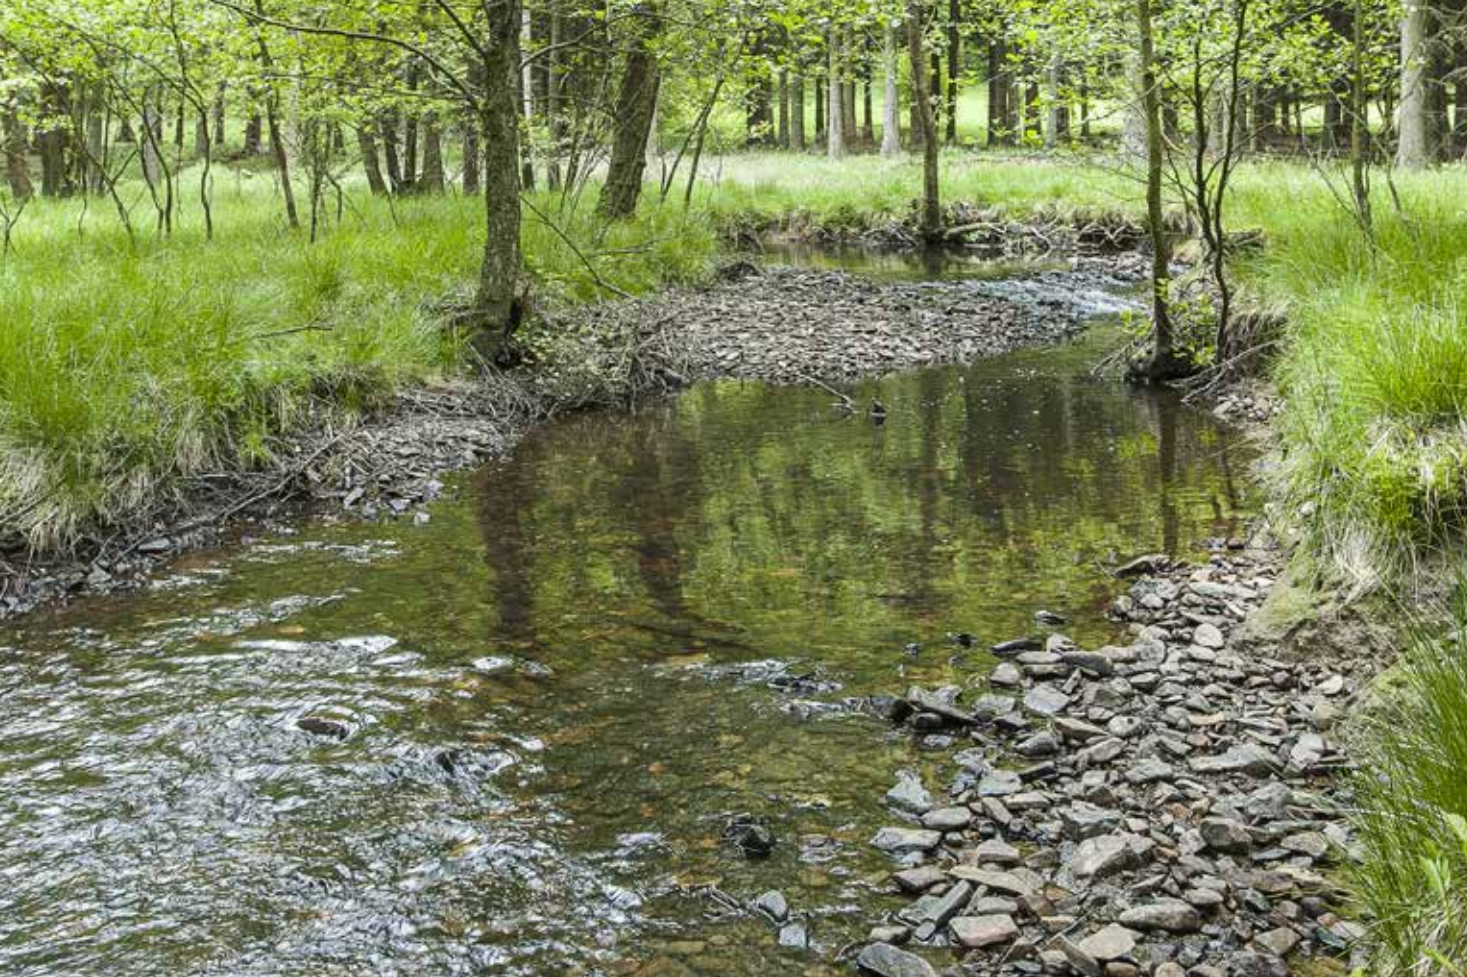
In the photo above the Große Schmalenau shows the typical sequence of calm pools and gravel banks with quickly-flowing water.

In the riffles, the banks of gravel are not only rapidly overflowed, the top 10 to 20 cm of the gravel is also permeated by oxygen-rich water, as the blue arrow indicates. This is the habitat of insect larvae like dayflies, the so-called interstitial.

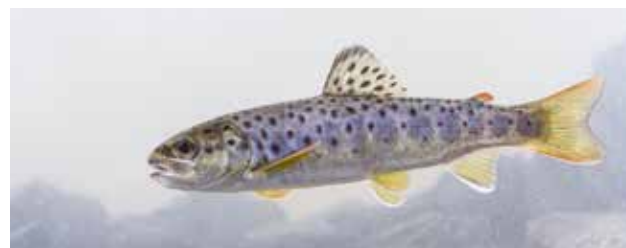
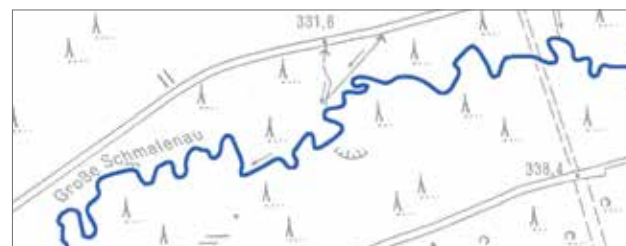
Trout find ideal spawning ground here. The eggs develop in the gaps between the gravel, surrounded by the clear water of the stream.

It is only possible for these structures to form if the stream meanders through a broad, flat valley and spills into the floodplain as soon as even small rises in water level occur.

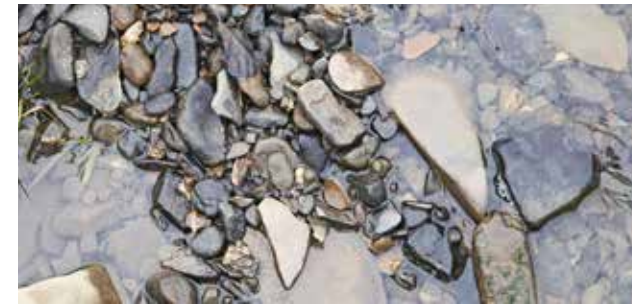
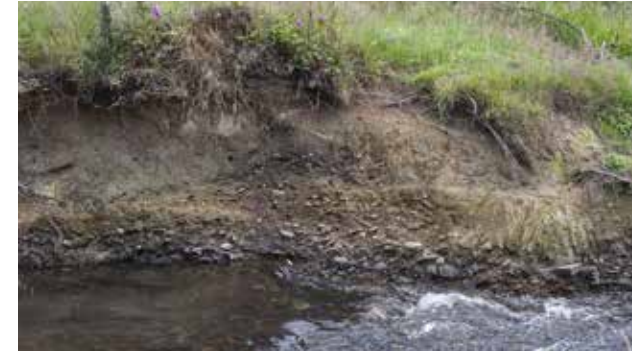
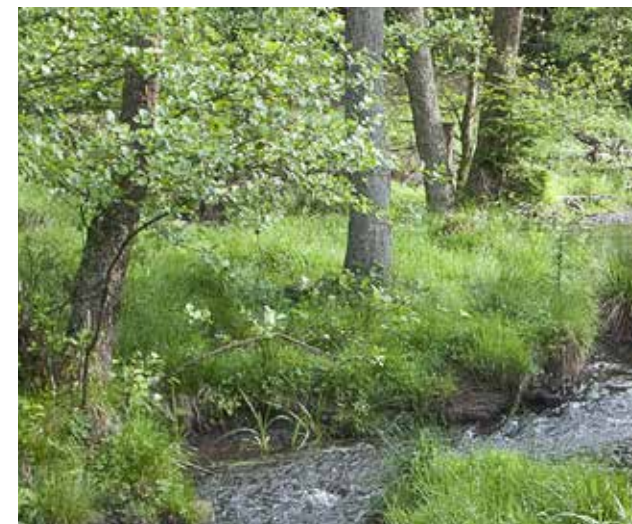
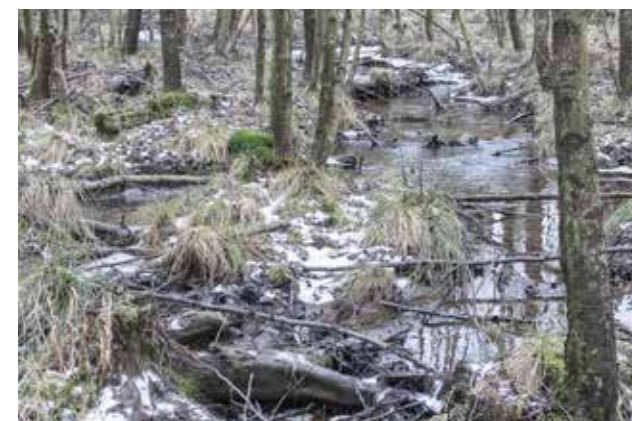
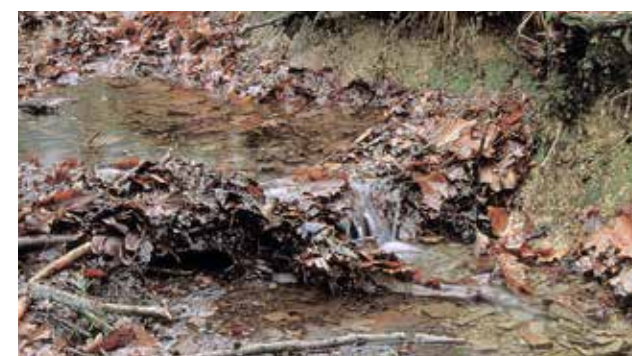
The gravel that lies in the valley floodplains under a layer of loam was formed from siliceous, i.e. low-lime rock. It is transported in the streams as so-called bedload at high water. The streams receive new gravel from the V-shaped valleys and by means of lateral displacement in the floodplain. The stream bed is only in equilibrium if the quantity of bedload transported downstream is in balance with the amount of new gravel coming in. This equilibrium is sensitive.

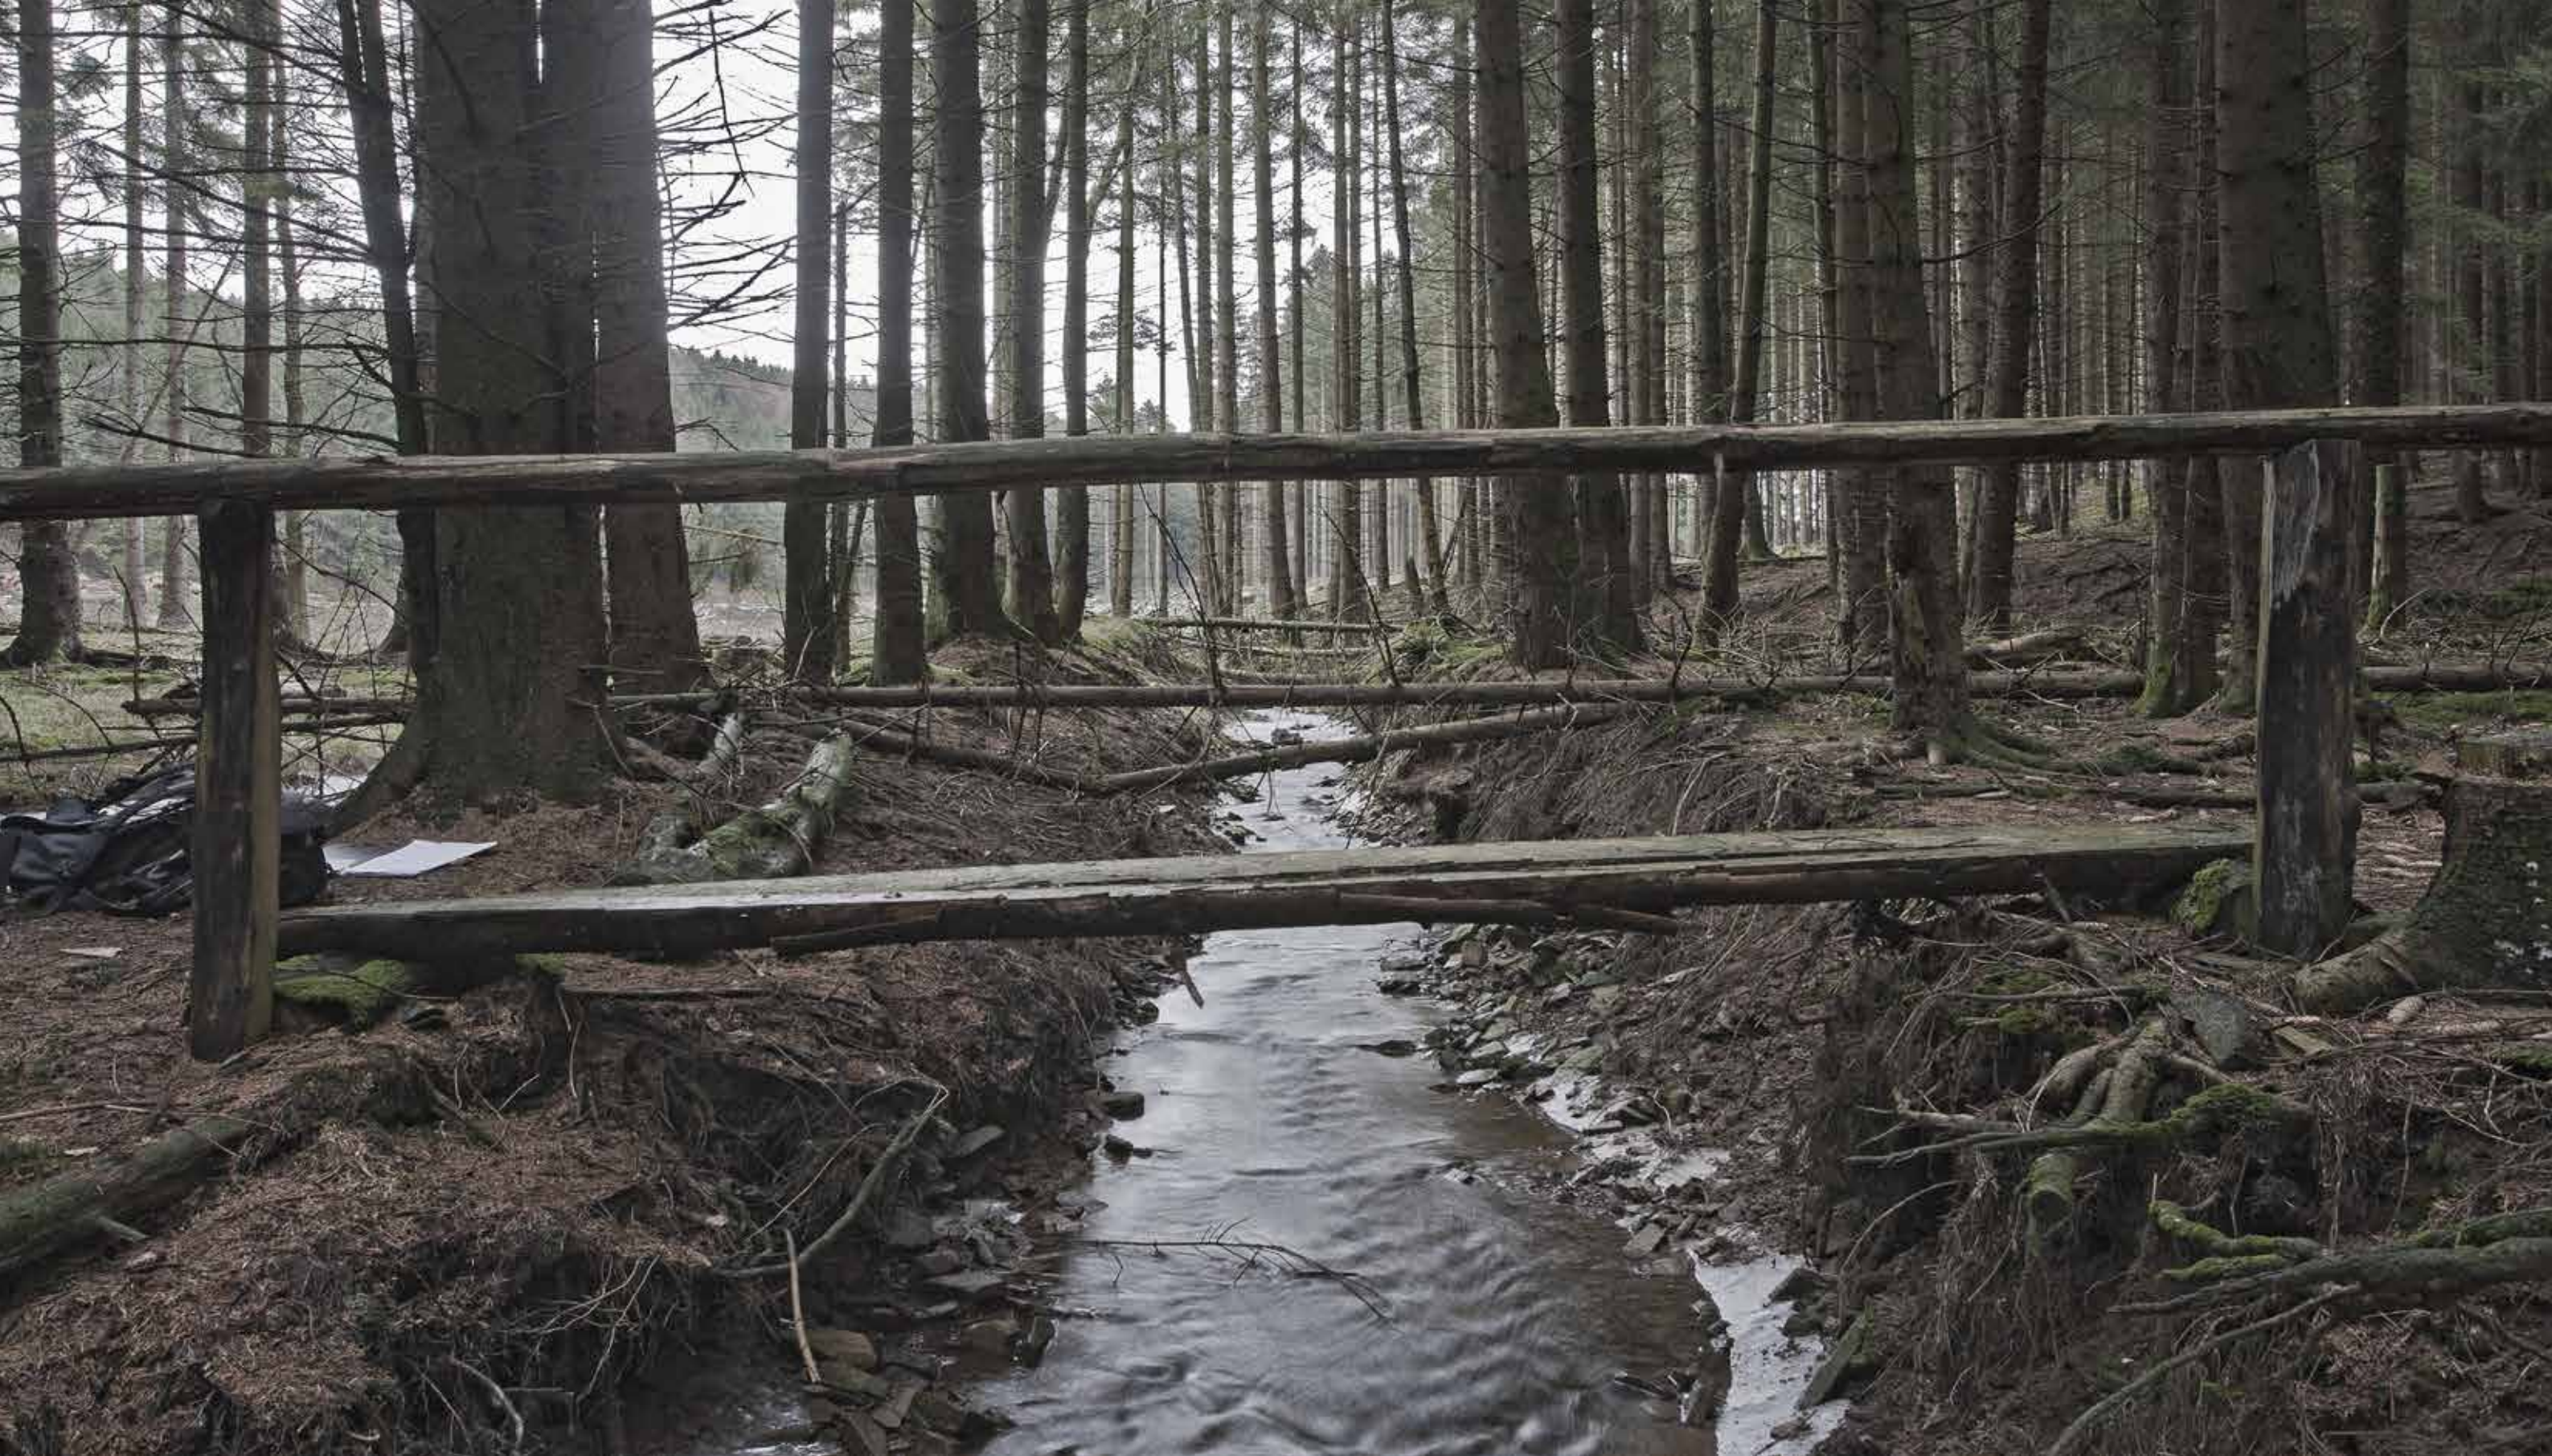
Channelized, deeply downcut, dark and without leaves: these are typical impairments of numerous sections of the streams in the Arnsberg Forest. The LIFE project had the aim of introducing a development towards near-natural conditions.

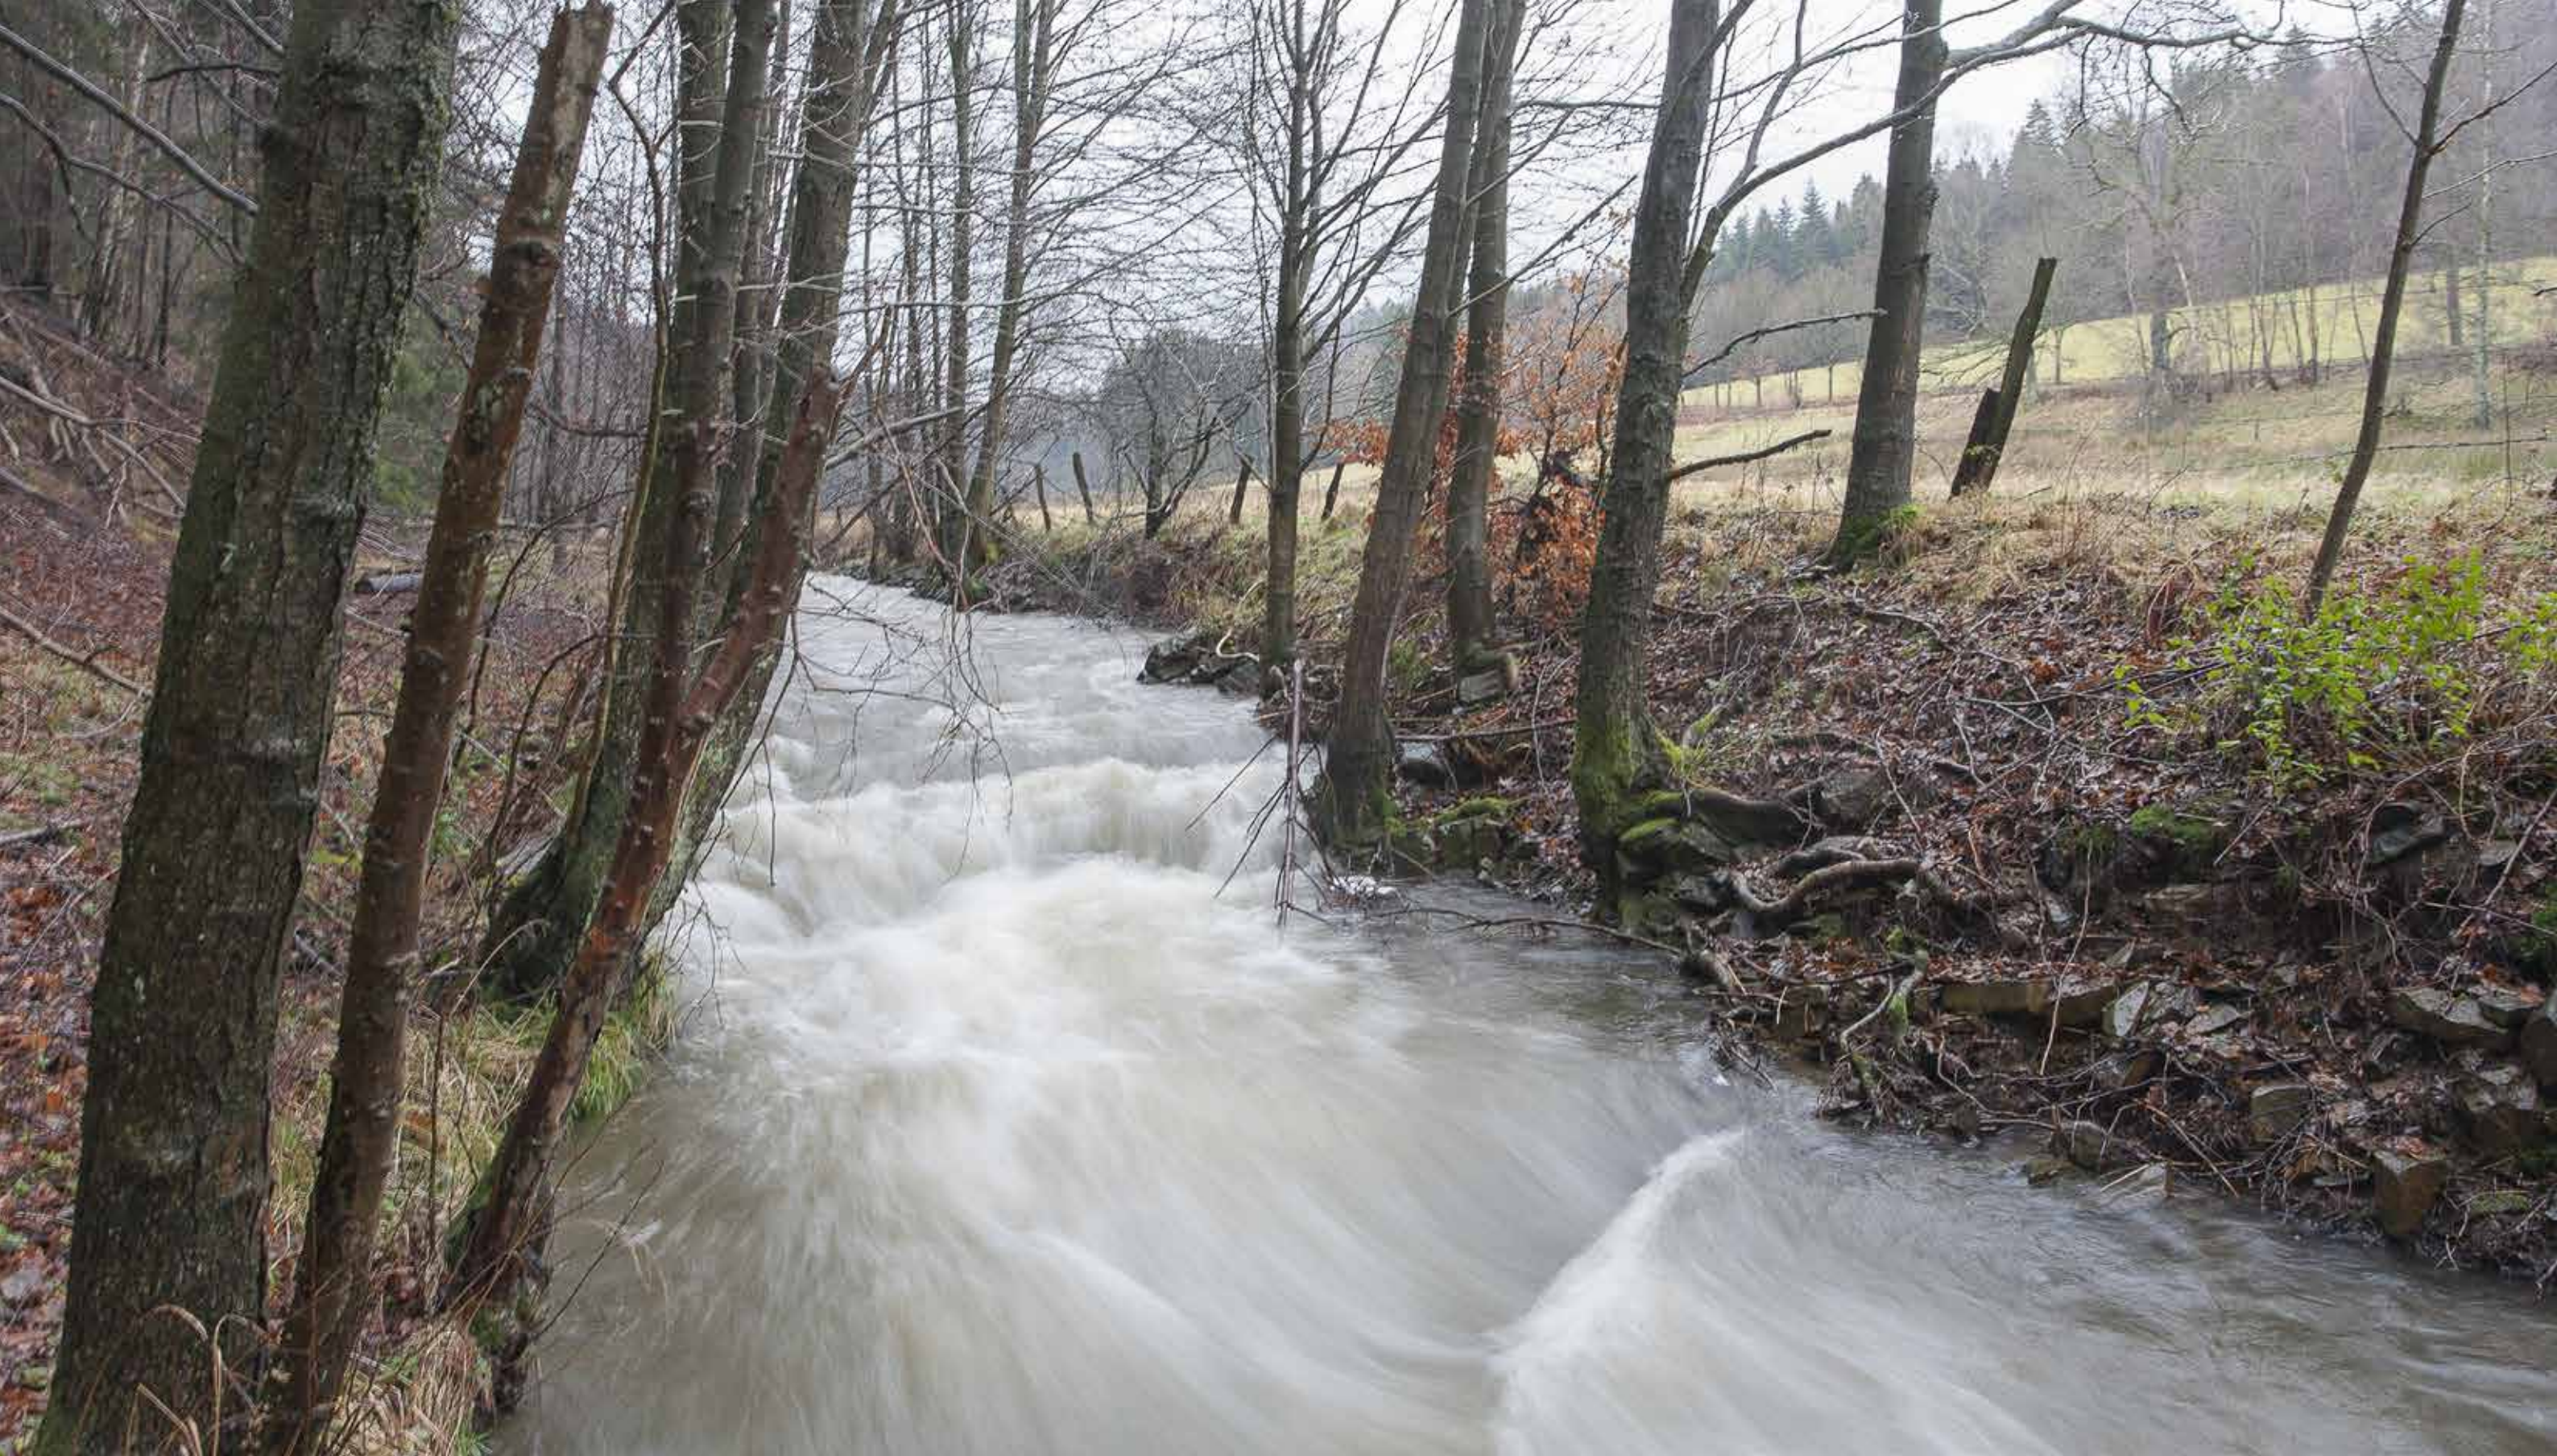
These pictures of high water rushing along the channelized lower course of the Große Schmalenau prior to the LIFE project give an idea of the forces involved. Fish, insects, leaves, branches, twigs and the gravel bed are simply washed away. The section of the stream is left impoverished. And the former floodplain, at the right of the picture, stays dry. It is deprived of the variety and vitality that would be brought by floodwater from an overflowing stream.

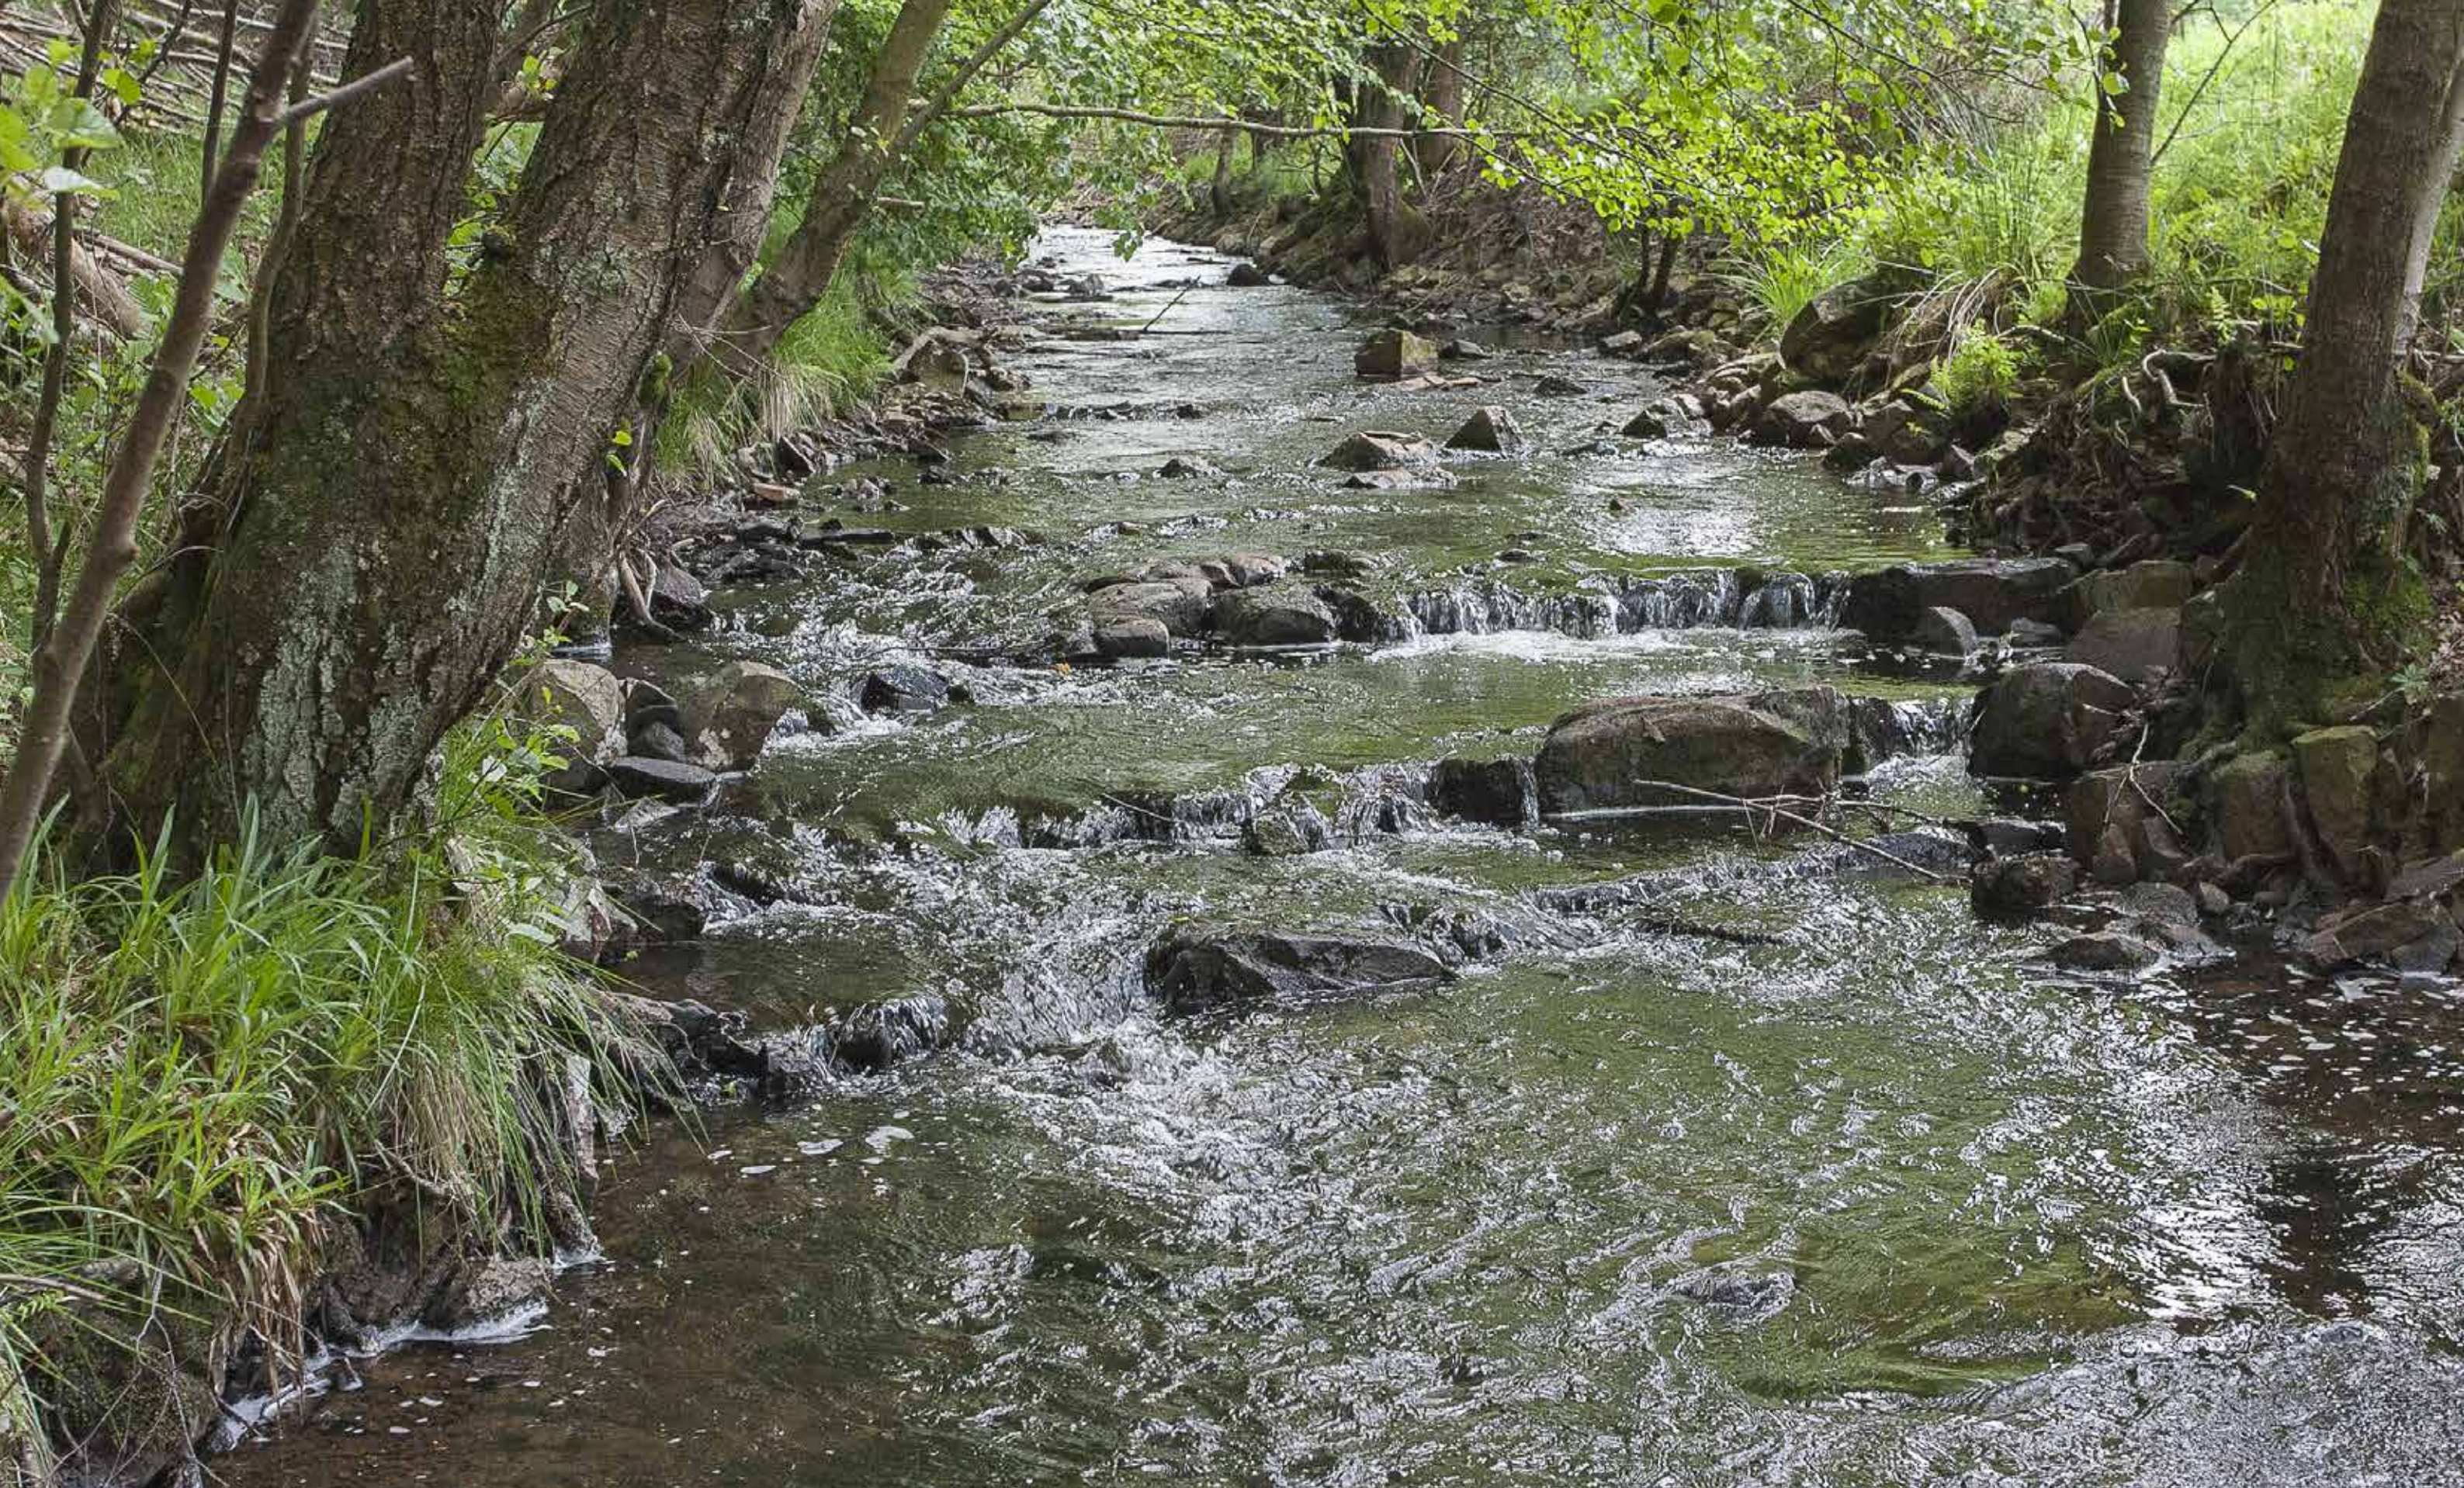
After the high water has subsided, the stream presents a seemingly idyllic picture. But this appearance is deceptive: the ridges of rock protruding from the water prove that the all-important bed of gravel is missing; carried away by the rushing torrent of water.

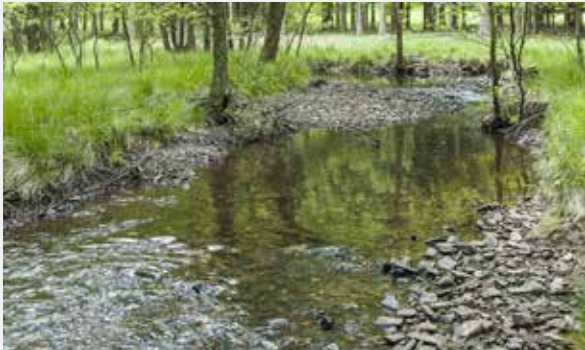
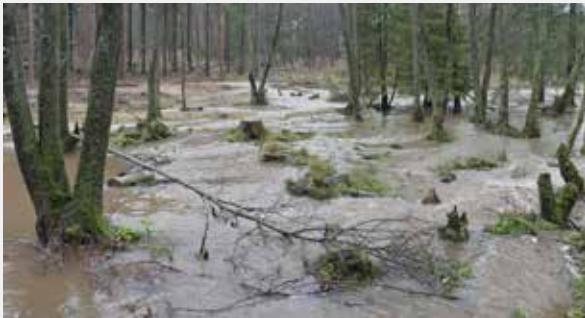
Near-natural

The course of the stream shows numerous loops or meanders (degree of sinuosity of 1.7 to 1.8) and cuts just a few decimetres into the floodplain. Its bed is mainly made up of gravel, and in the shallow riffles the rapidly-flowing, oxygen-rich water permeates the gravel banks. This so-called interstitial is the habitat of insect larvae and the spawning place for trout. High water quickly overflows into the surrounding floodplain, because the stream can only transport a limited amount of water. This protects the stream and its bed against the great force of rushing water, while young fish and insects are not carried far, and the floodplain of the stream benefits from the high water.
