## Stream valleys in the Arnsberg Forest

LIFE-Project 2009 - 2014

# LIFE Project „Stream valleys in the Arnsberg Forest“

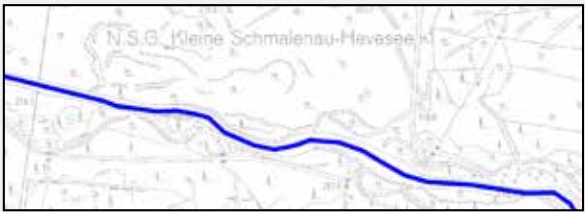
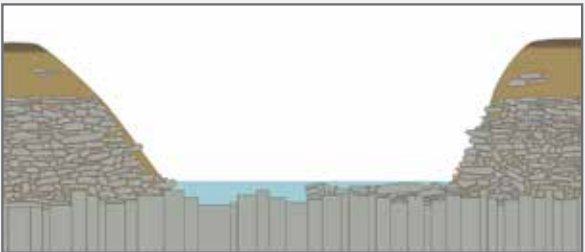
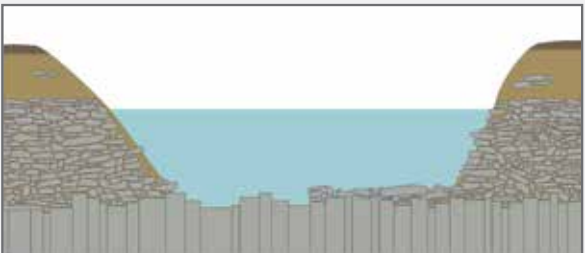
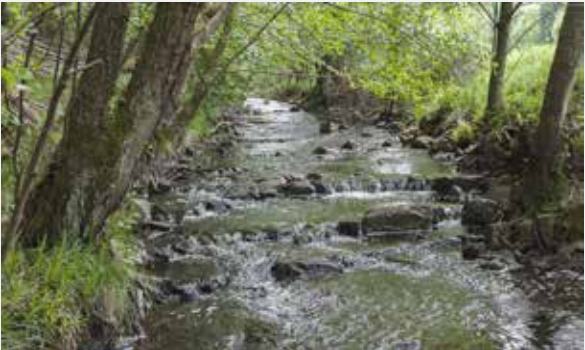
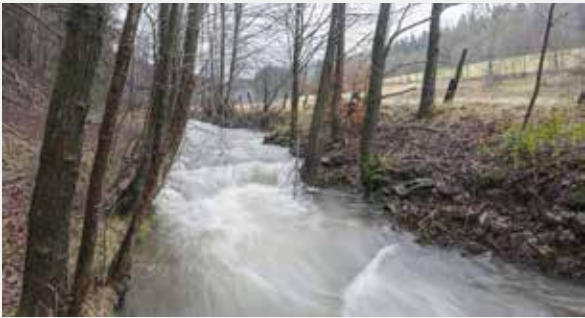
Non-natural

The stream is straightened and channelized, and has cut down so far that the bedrock has been reached. Experts call this "bed erosion". The deeper the bed of the stream, the greater are the forces exerted by the water. The damaging erosion only stops when a stratum of solid rock is reached. So little gravel is left that the all-important interstitial is missing. High water flows at great speed in the deep, channelized bed of the stream. The torrent tears everything away – gravel, insects, snails and young fish. The high water cannot overflow into the stream floodplain, which therefore lacks vitality; no seeds are carried into it by water.

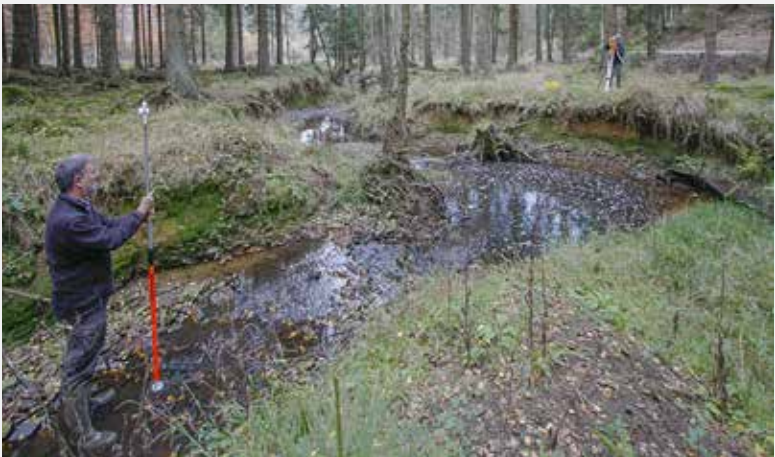
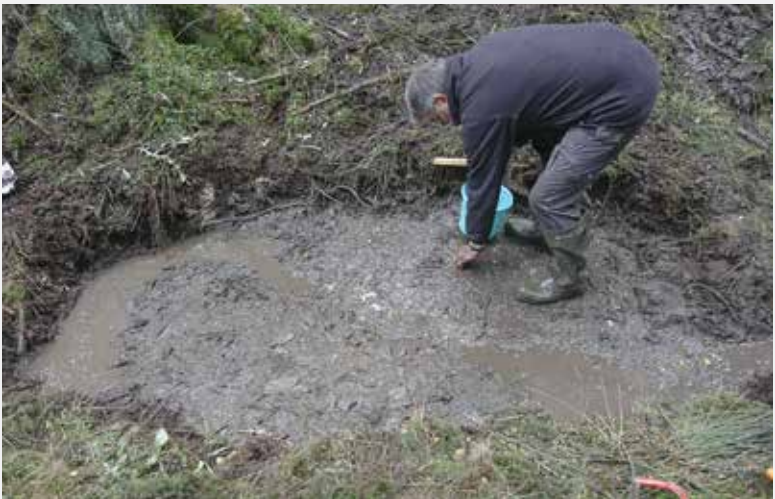
At the Kleine Schmalenau it was possible to directly compare an eroded profile with a near-natural stream profile. Immediately beside the modern course of the stream, a slight depression in the floor of the spruce forest could be recognized as a rudiment of the former, near-natural course of the stream.

The near-natural former stream profile was cleared of debris and both the profiles were measured.

There are big differences between the eroded, channelized profile and the historical, near-natural profile. This can also be seen from a simplified comparison of the key data for the bankfull discharge flow of the near-natural and non-natural cross-sections. The creatures in the stream and the gravel of the stream bed are subjected to considerably higher flow forces in the non-natural stream profile. In addition, the floodplain of the non-natural stream is only flooded in the event of very extreme high waters, which occur very infrequently.

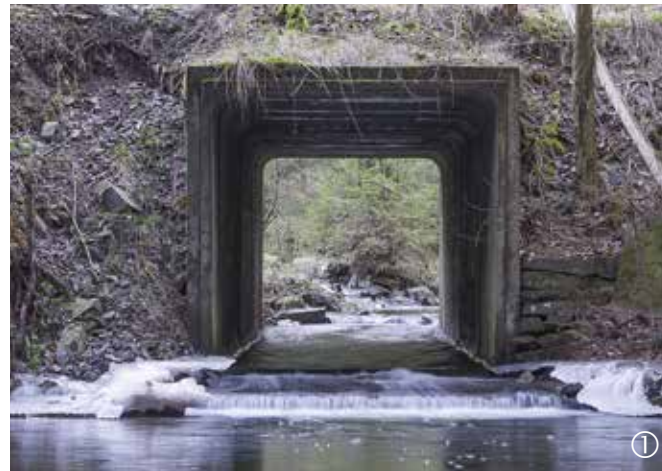
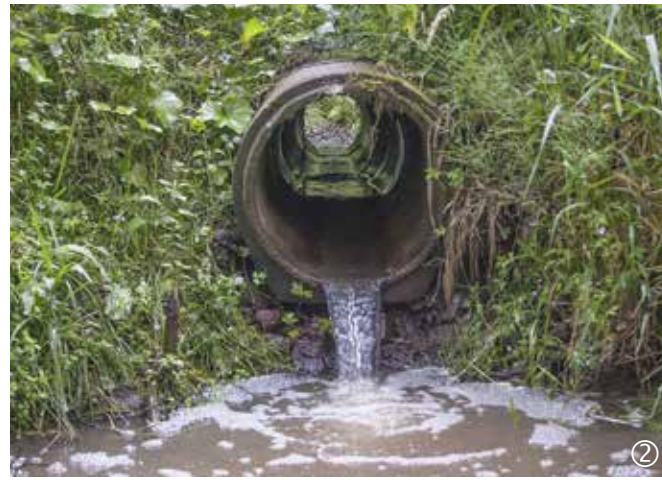
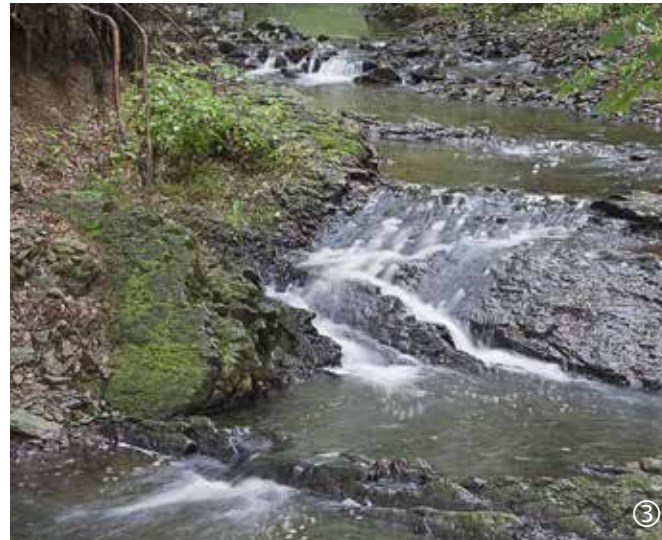
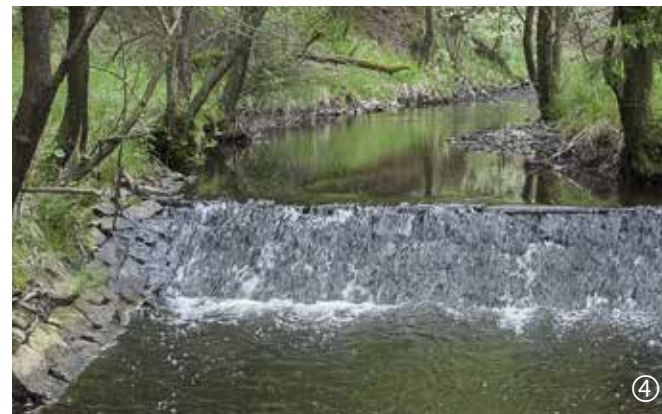
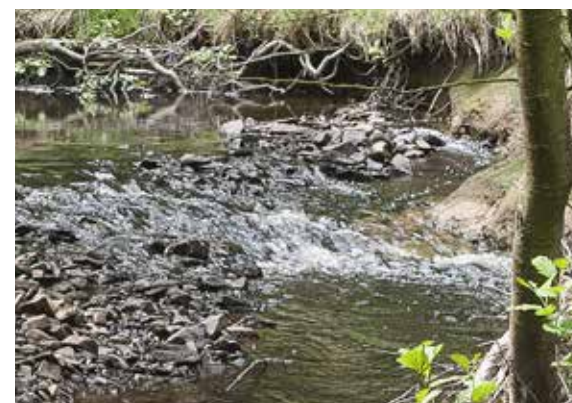
① An adequately large culvert was unfortunately installed too high. Its smooth concrete bottom and the shallow flow of water, together with the cascade at its end, make this structure in the Große Schmalenau an impassable obstacle for many creatures.

② This is a very typical example: a pipe that is far too small, with a cascade at its end, isolates this small tributary stream from the Heve.

③ This cascade in the Kleine Schmalenau is one metre high and was the result of bed erosion caused by channelizing.

④ This weir was built in order to feed water into the ditches of the earlier meadow irrigation system at the lower stretch of the Große Schmalenau. It was impassable for many creatures, but is also a significant historical feature of the landscape.

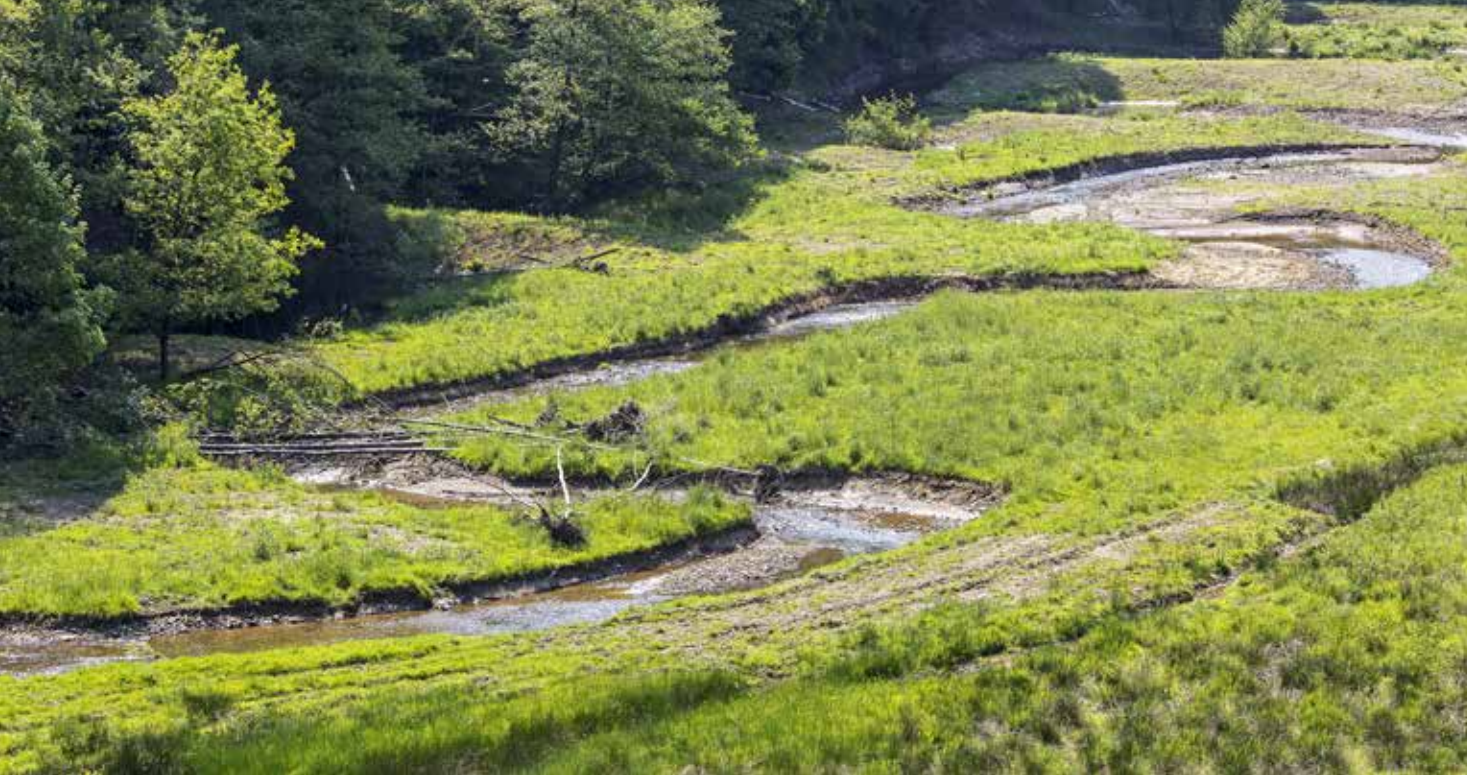
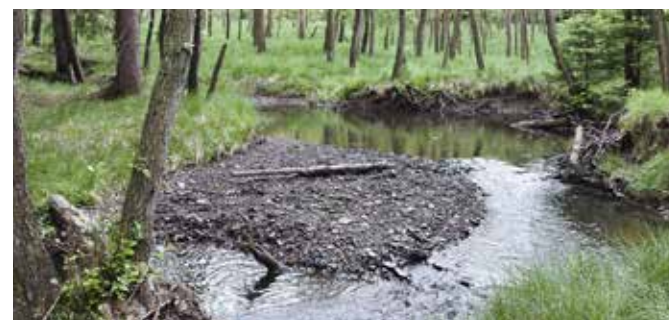
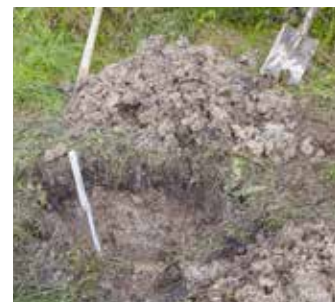
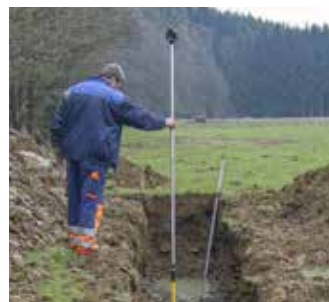
Nature provides the model: the meandering form of the natural stream course, the broad, shallow bed of the stream, the ratio of the natural length of the stream course compared to the length of a channelized stream ("degree of sinuosity") of approx. 1.7 to 1.8, the dimensions of the stream loops, and the profile of the stream.

In still-existent old stream courses, the gravel bed is exposed at the shallowest points and measured. In areas where near-natural stream courses can no longer be identified, test trenches are excavated. These provide good data relating to the thickness of the alluvial loam.

The digital terrain model is used for the calculation of contour lines at 10-cm-intervals, which are then superimposed on the coloured, horizontalized terrain model. Additionally measured points in the terrain can be used to correct the terrain model. Together with the parameters obtained from the natural stream courses, this provides the basis for the implementation plan. The quantity of soil to be excavated and the quantity needed for the blocks of soil to plug the channelized course are then determined with the aim of balancing the quantities locally (blue line: new stream course, brown hatched: backfills, blue dots: planned stream bed heights, brown dots: planned terrain heights, yellow hatched: slight depression, red dots: measured terrain heights).

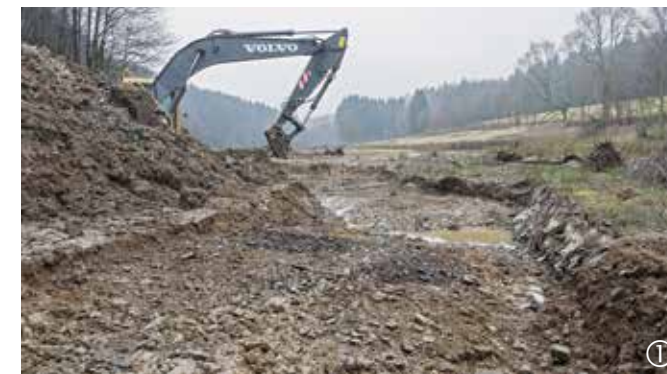
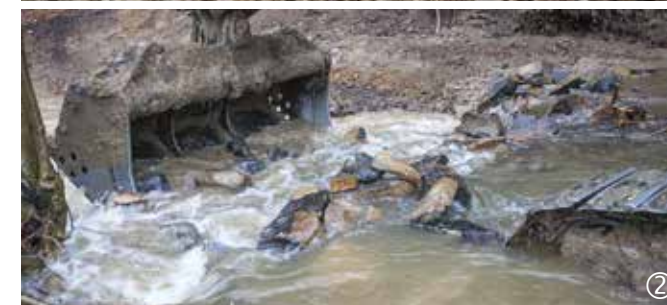
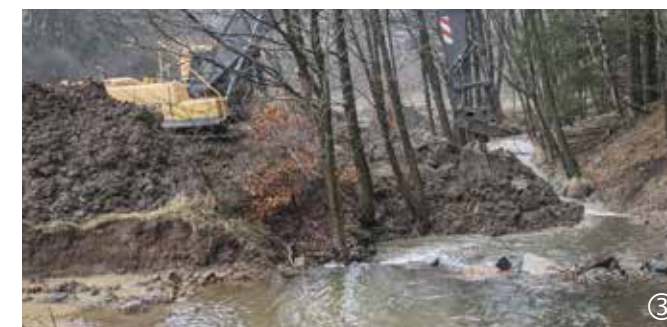
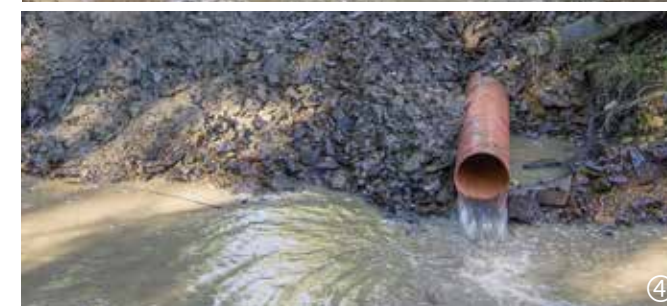
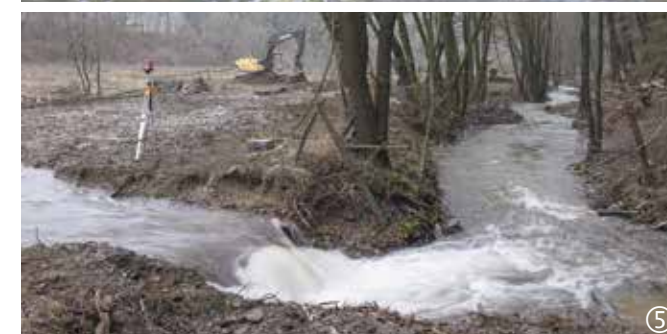
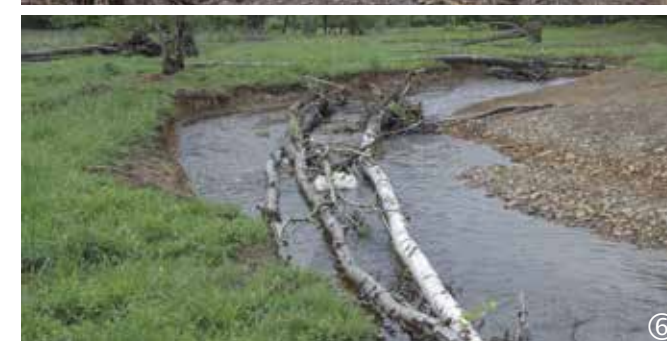
The course of the new stream was plotted and pegged out in the terrain. ① Only the overlying loam of the floodplain was excavated, not the gravel, even if its surface level is higher than the planned bed of the stream. The reasons: It is a favourable initial situation for the new stream if its bed level is as high as possible. This means that quick widening of the course will take place, preventing downward erosion of the bed. The momentum of the stream then carves out the gravel bed to create the typical sequence of pools and riffles.

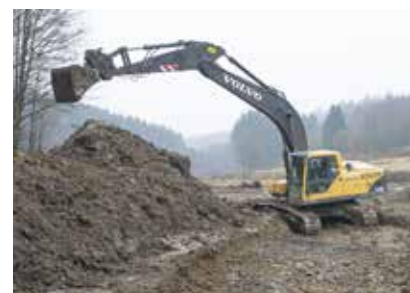
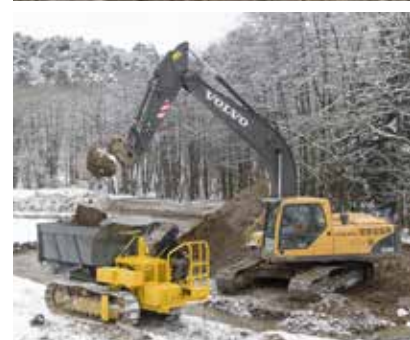
The construction work proceeded in the direction of flow. ⑤ The picture illustrates the different positions of the water level before and after the restoration measure.

At some places trees had to be removed to allow construction of the plugs, or if they obstructed the crossing points of new loops and the old channelized stream course. ⑥ These trees were placed in the new stream as deadwood.

The masses of loam were normally moved with the excavator; small transport vehicles that do not harm the soil were only used by way of exception.

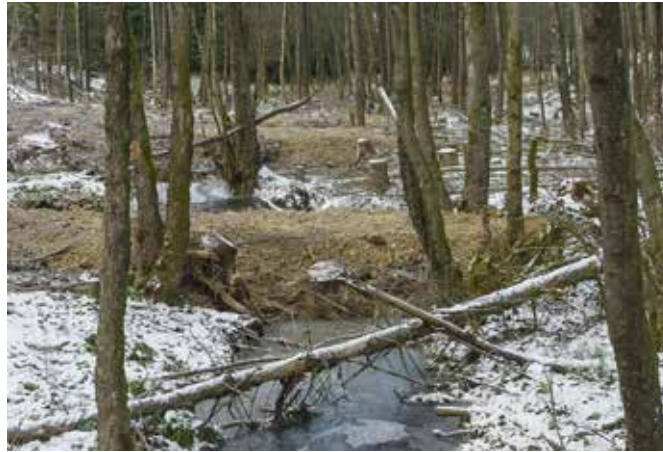
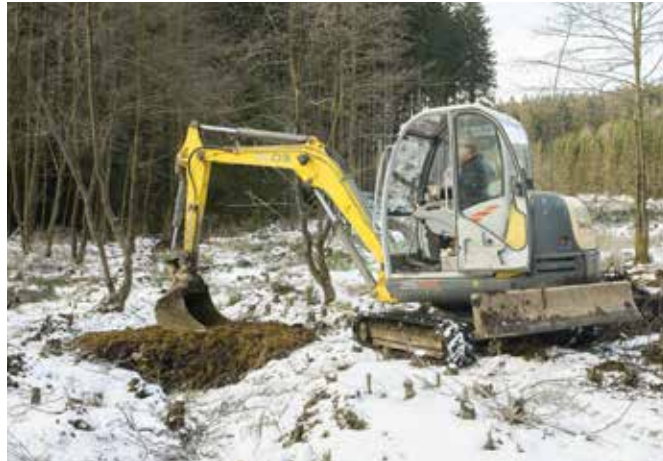
... big effects! If the natural stream was channelized and shifted to the side of the valley, but the original meandering course still exists, as was the case here in the upper course of the Große Schmalenau, the required measure is obvious: the channelized stream course should be closed and the original course reactivated.

High water in the upper section of the Große Schmalenau. The old channelized course was plugged and the still-existent natural, bed of the stream meandering through the alder forest was activated.

In such cases, however, the quantities of soil needed for completely filling the channelized stream course are not available, as the artificially enlarged and deepened erosion profiles are always several times larger in volume than the near-natural stream. For this reason, it is particularly important to construct safe plugs of floodplain loam such that high water cannot flow over them. Otherwise, they would inevitably be destroyed, with the unwanted result that the channelized stream course would be reactivated.

Drainage ditches in the floodplain can best be closed off with the aid of a small, light excavator that does not harm the soil. Excavated cohesive soil from the adjacent area is dumped into the ditch and compacted into a firm plug by driving the excavator over it a number of times.

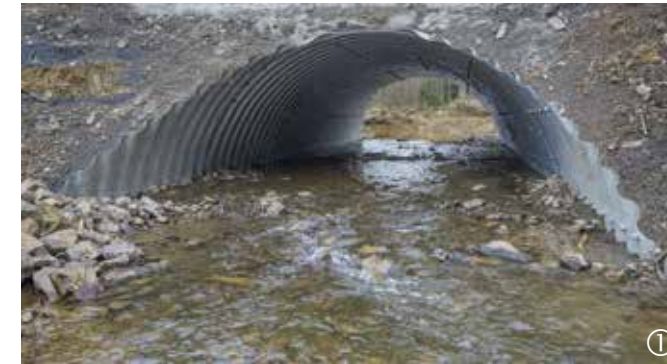
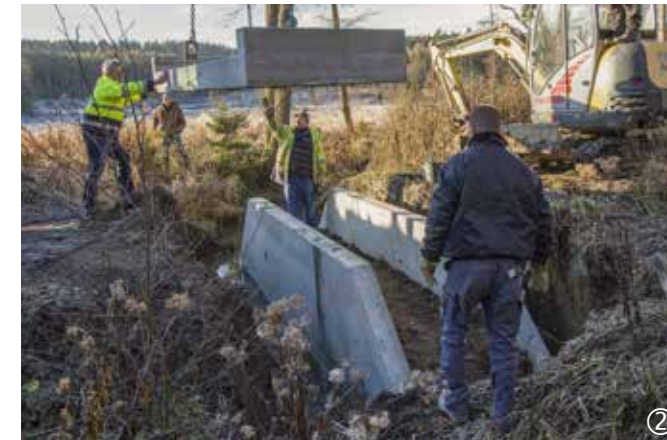
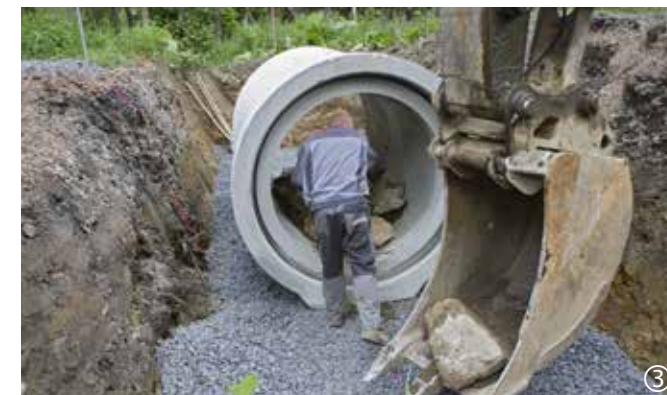
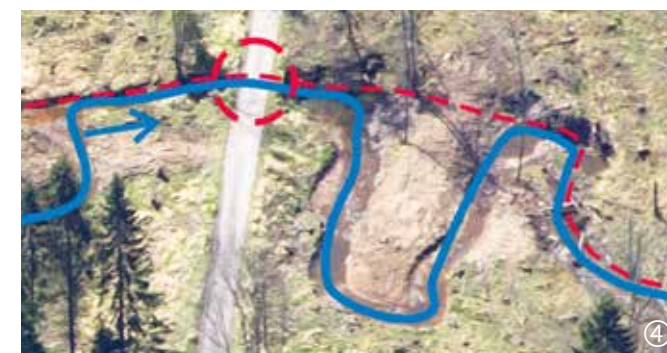
① If the road crossing has a large span width, an extra high egg-shaped profile of corrugated steel can be a good solution.

② If the span width is small, a concrete box profile can be used.

③ In the case of very small streams, large concrete pipes can even be used. These are cheaper than made-to-measure concrete box profiles.

④ In every case, a check was first made to see whether lengthening of the stream's course below the road crossing would make the structure passable. Here, this procedure is illustrated by example of the Kleine Schmalenau: Red marks the channelized course, blue is the course after lengthening of the stream by adding a further loop. Lengthening of the course results in a higher-level stream bed at the road crossing structure, and thus in a higher water level. In some cases, this is enough to make the structure permanently passable. The advantage of this solution: Significantly lower project costs because the existing structure can be retained.

Seven impassable road crossing structures were replaced with new ones. The decisive factor for retaining or replacing a structure is that the created bed of the neighbouring stream must be 30 to 40 cm thick, and that the conditions downstream of the structure must exclude the possibility of future downcutting due to bed erosion. To ensure that these prerequisites are achieved, the course of the stream is lengthened if necessary by adding a further loop.

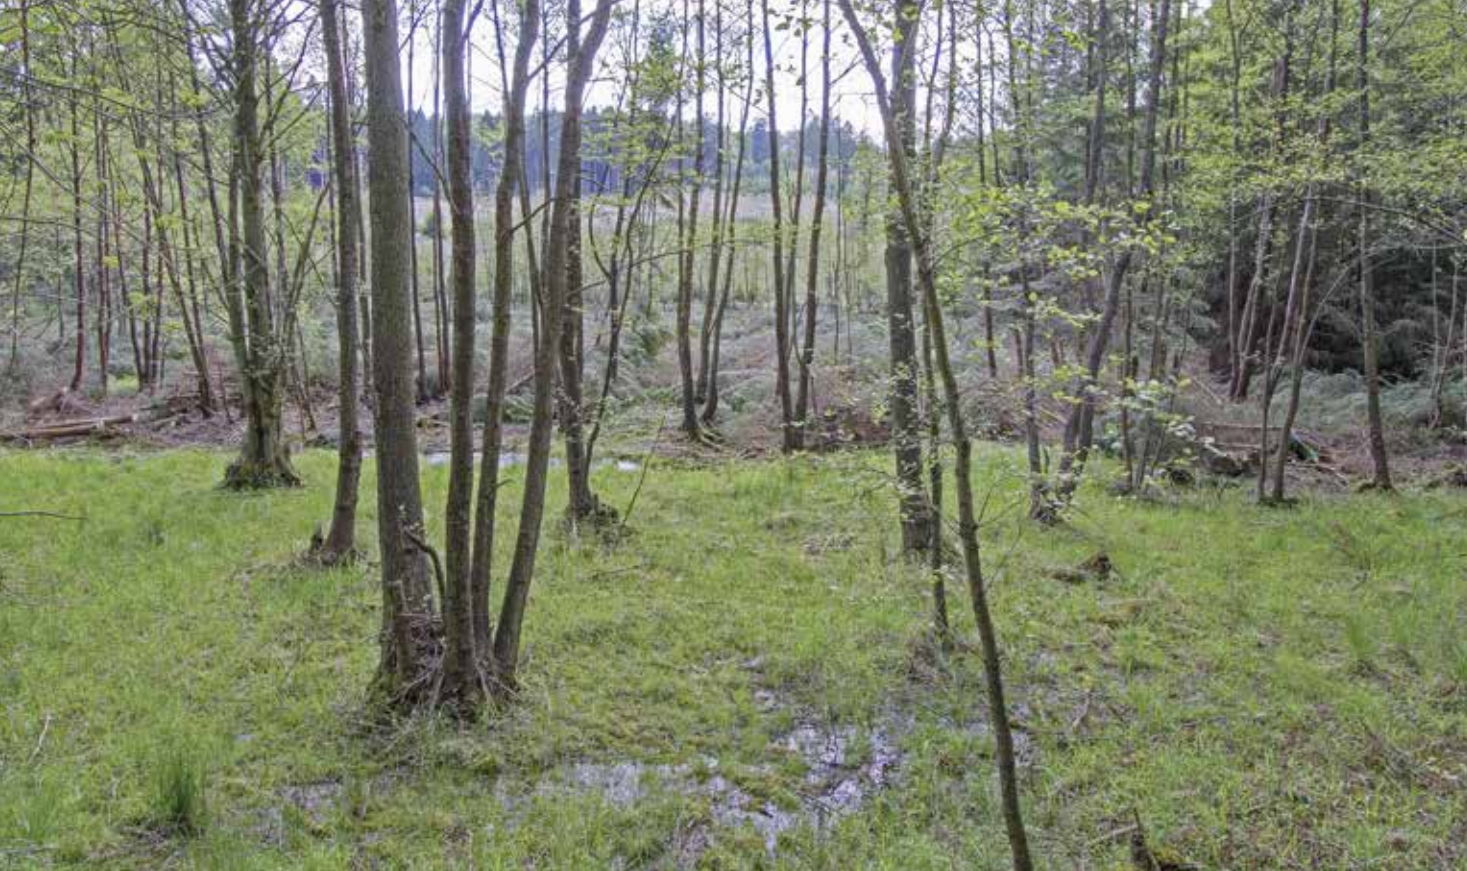
⑤ In one case, generous lengthening of the Große Schmalenau made it possible to bypass an old weir that had been used many decades ago for feeding water into the meadow irrigation system. Passability of the stream was successfully restored while retaining the historical weir, which is a significant landscape feature.

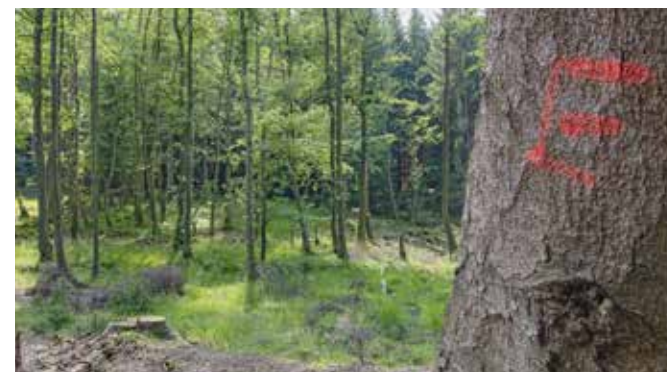
The old spruce trees to be removed were marked by the district forester, and the felling directions and sites for processing the felled spruces were defined.

The skid trails to be used by the forestry contractors were marked; the letter "E" indicates the final point up to which the machines were allowed to drive.

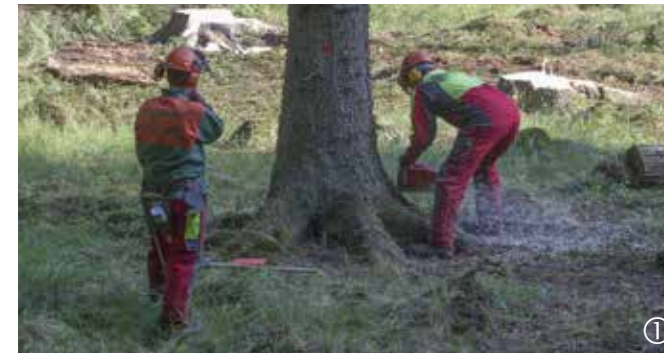
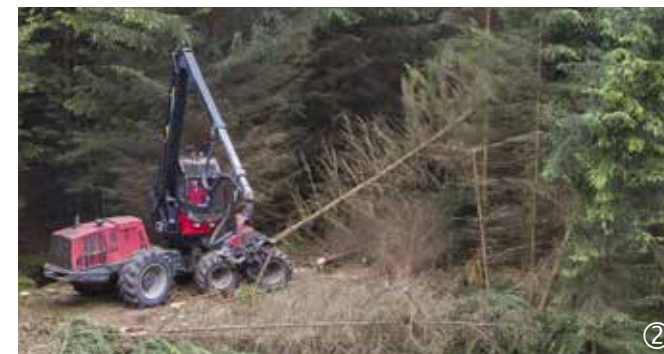
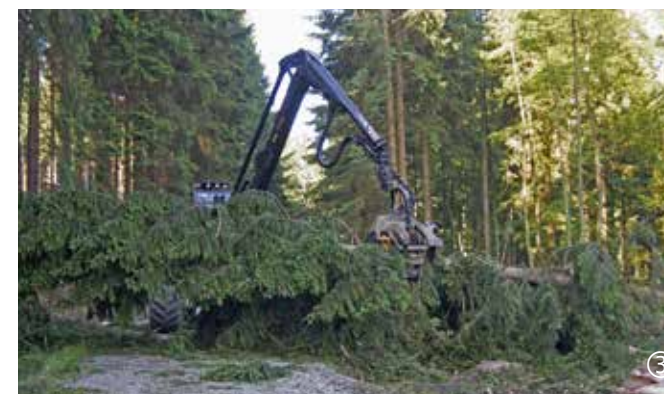
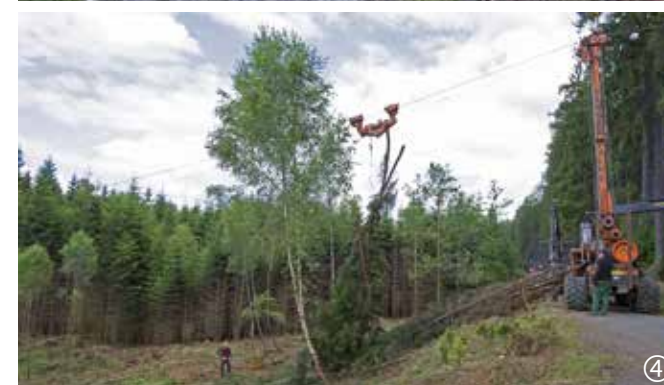
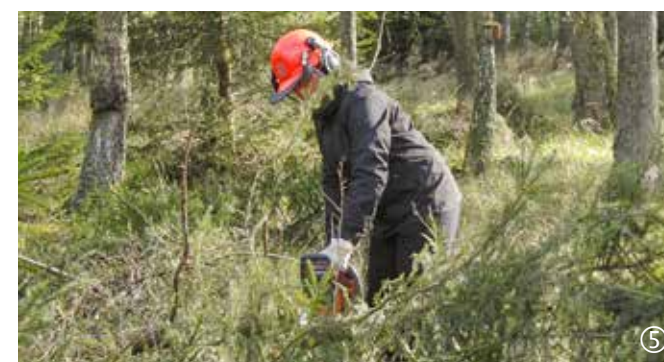
Old spruce trees were generally felled using power saws ①. The soil conditions seldom allowed a forestry harvester ② to drive into the area and undertake the felling. The floodplains were off-limits for forwarders, because of the especially high soil loading of these vehicles.

③ Sometimes it was possible for a forestry harvester to pick up felled spruce trees and delimb them outside the floodplain. ④ However, the spruces were usually dragged by rope out of the floodplain as a full tree. If the distance was too great for a rope, or if the soil was too wet, a crane truck was used.

⑤ Very small saplings were cut with a brush-cutter. Saplings of this small size could be left lying in the area.

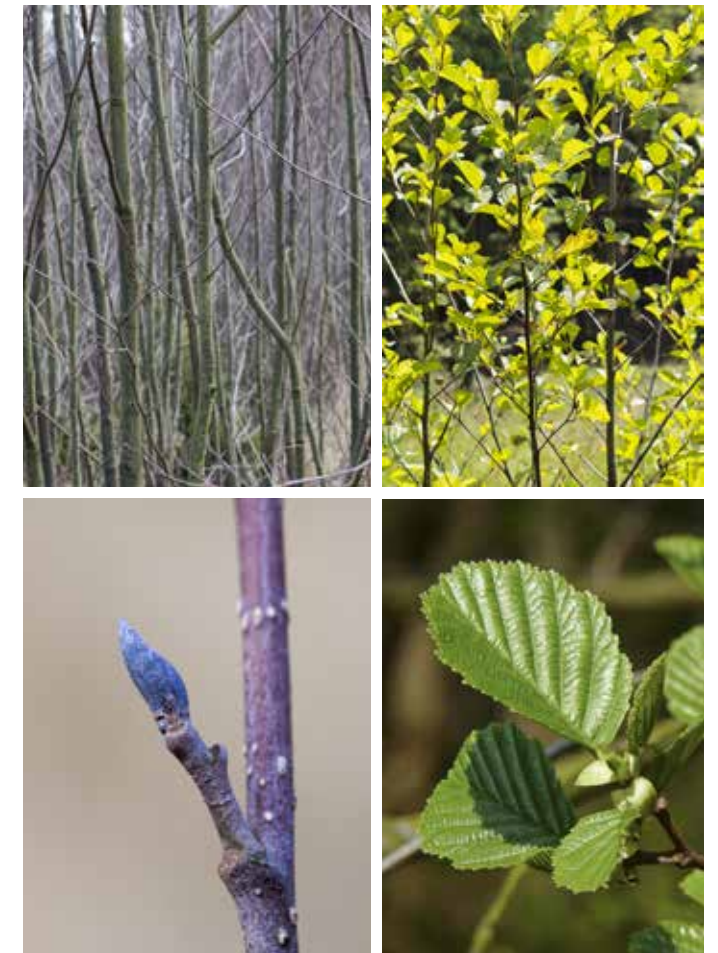
Natural regeneration of black alder in the Heve valley

A very special combination of events proved favourable for natural regeneration of alder forest in some valleys in the Arnsberg forest: First, Hurricane Kyrill blew down dark spruce plantations on 18th January 2007, then a severe flood occurred on 9th August 2007. This flood washed gravel and mud into the floodplain and thereby created an ideal germination bed for black alders. Innumerable saplings took root and grew in densely-packed stands. In the course of time, some of these will dominate and others will die away. This is a new alluvial alder forest in the process of development.

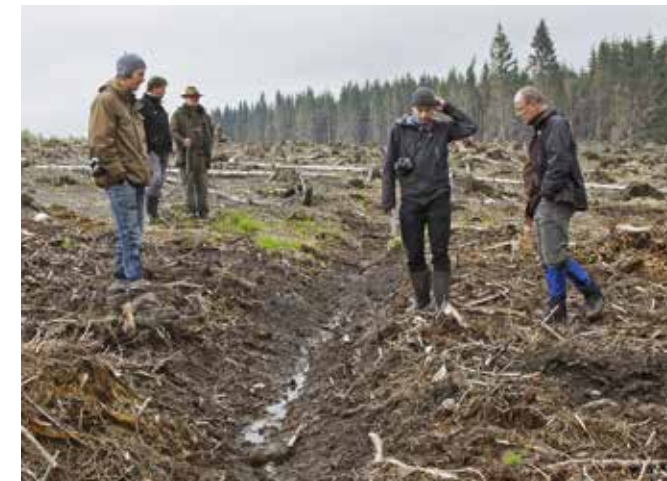
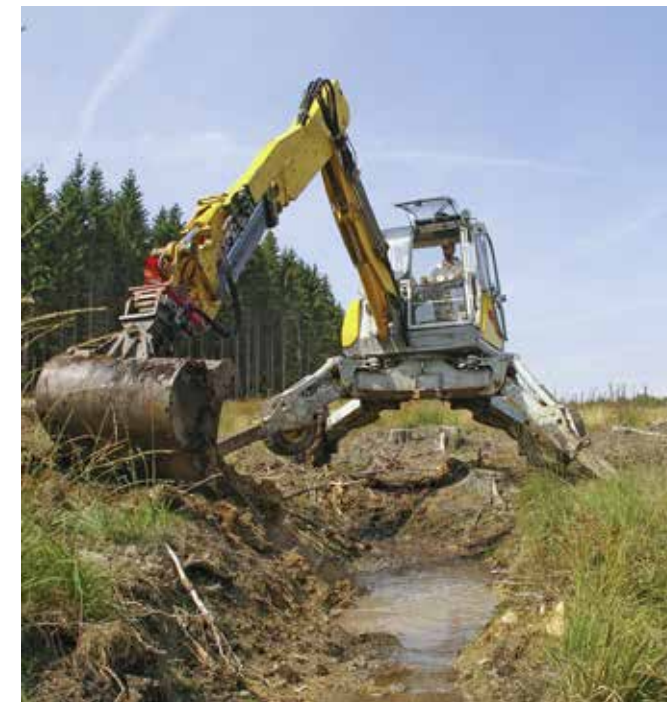
The drainage ditches are closed off by the following method: At the chosen location, the bog soil is first stripped down to the inorganic material. Upflow of the future closure plug, inorganic soil is excavated and carefully placed to form a broad block of soil. This is then compacted with the excavator bucket to form the plug. To ensure that water does not flow around the plug, but stays in the area to re-irrigate the bog, at least one trough-like opening into the bog is made in the wall of the ditch. The block of inorganic soil is then covered with bog soil.

To enable restoration of the bog, drainage ditches had to be plugged at 46 places.

The first attempt at closing off the ditches met with failure. The sensitive bog soil could not support the 8-ton excavator that was used, and the machine's crawler track could not cope with the spruce tree stumps and wet areas. However, the second attempt went perfectly: This time, a walking excavator was used.
